BEFORE THE NEBRASKA DEPARTMENT OF ENVIRONMENT AND ENERGY

IN THE MATTER OF)	
AltEn, LLC,)	CASE NO. 3546
)	
FID # 84069)	EMERGENCY COMPLAINT
)	AND ORDER
Respondent.)

Release of Thin Stillage and Cattle Manure from Digester at AltEn LLC, IIS #84069, RA
#021221-NH-0845

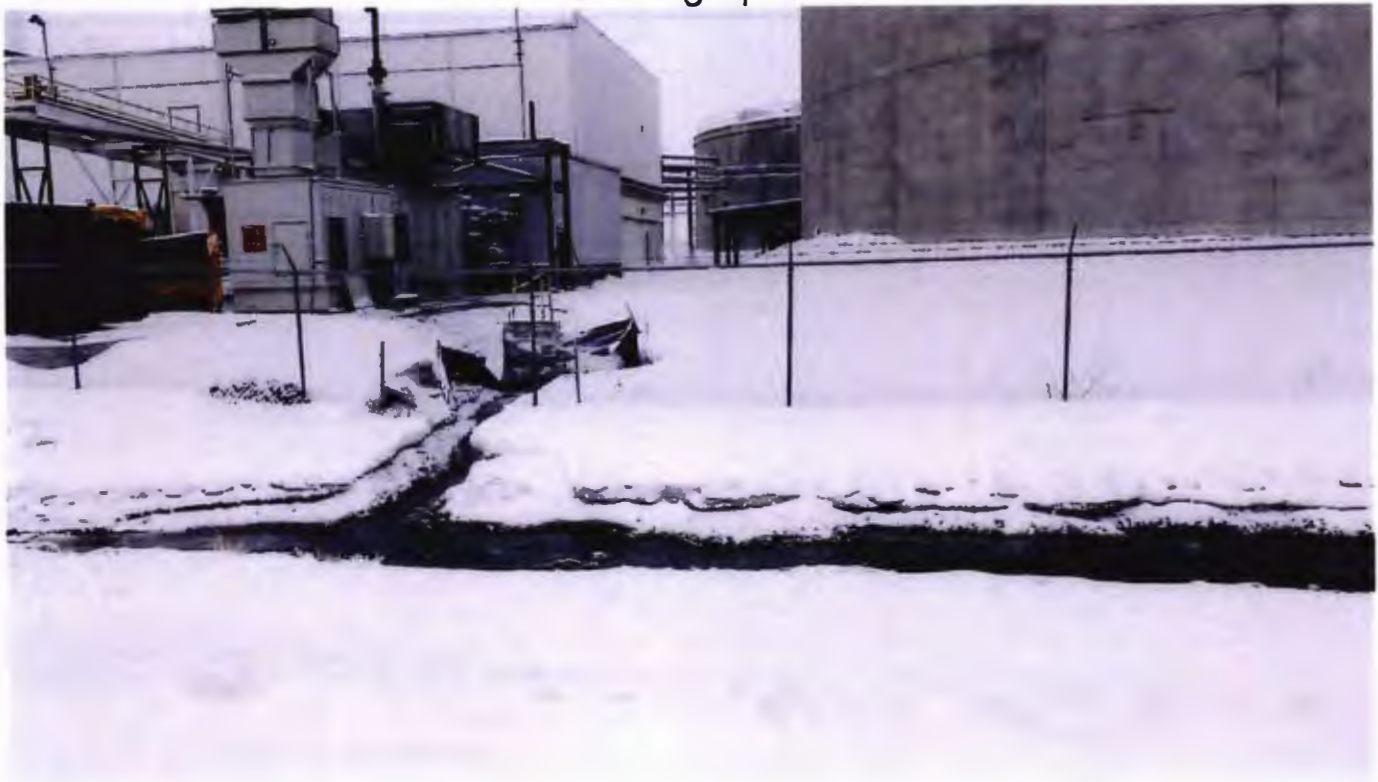
Photo 1

Mr. Peterson drove me to the digester. Upon arrival I observed wastewater conveying from the southwest side of the digester, photo 1. I asked Mr. Peterson if the break is located on the southwest side. Mr. Peterson stated no and drove to the southeast corner. There is heavy flow cascading over the hill into the adjacent ditch, photos 2 and 3. We then exited the truck and walked to the digester. The ruptured pipe is located on the east side splashing and spraying against the digester, photo 4. The surrounding area east, west and north are filled with wastewater, photos 5 and 6. I asked Mr. Peterson if the tank was full. Mr. Peterson confirmed the tank contained four million gallons. I asked what containment activities have been employed. Mr. Peterson stated the break is below ground. The water pressure and break area are making management difficult. Mr. Peterson stated they installed two trash pumps, photos 7 and 8.

Description: This photo depicts water flow from the storm water conveyance system. Water is entering the ditch flowing east along the south side of the digester.

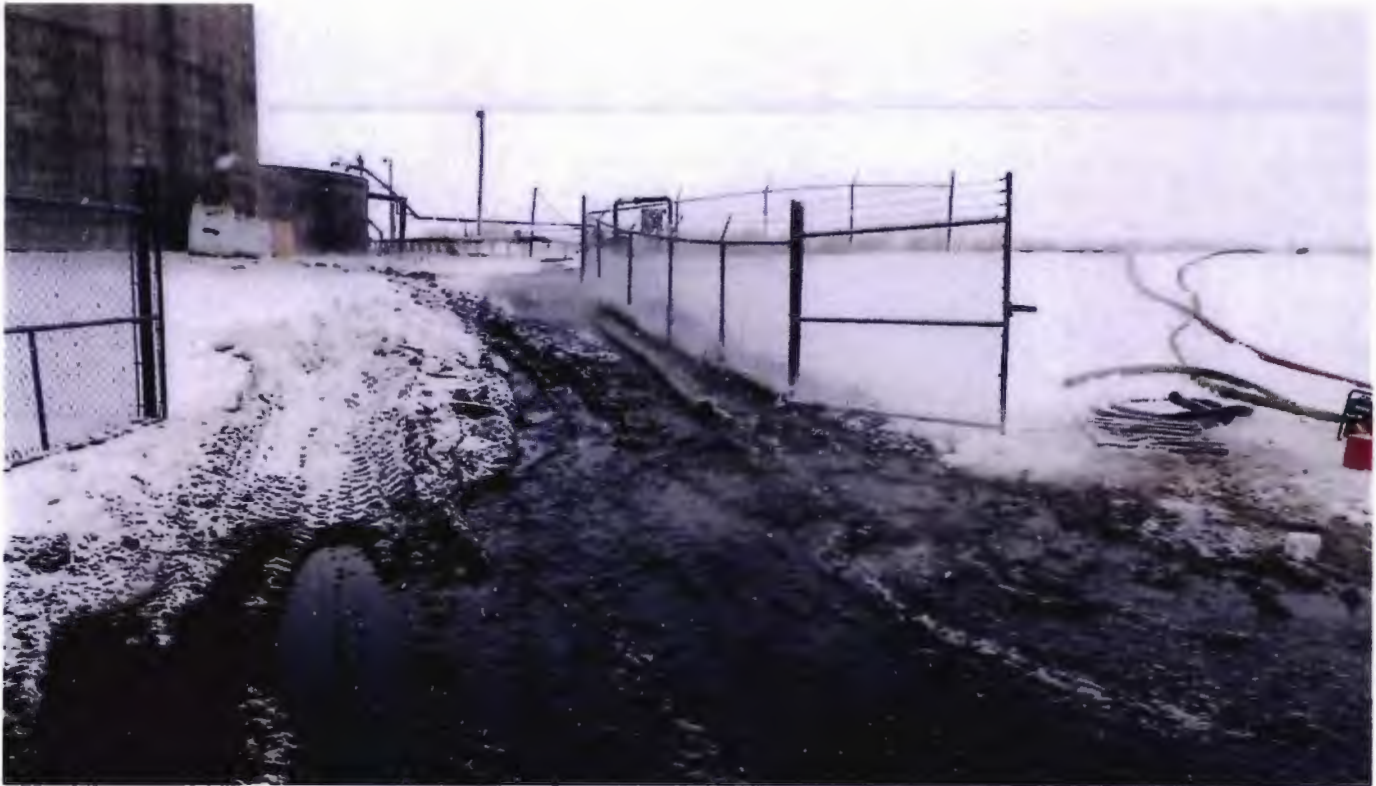
Photo 2

Description: This photo depicts cascading water exiting the southeast side of the digester.

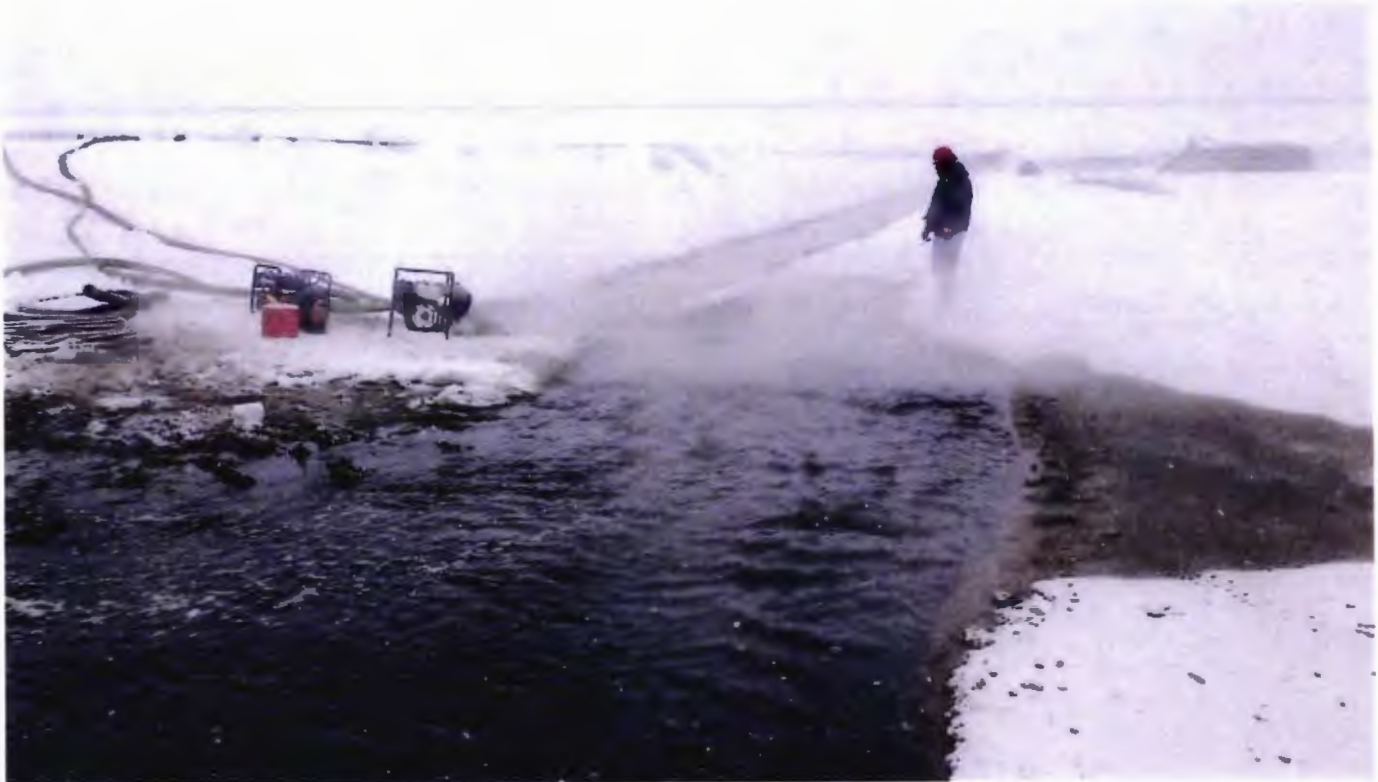
Photo 3

Description: This photo depicts water entering the ditch and flowing along the emergency lagoons. Also depicted is the trash pumps installed to transport water into the emergency lagoon.

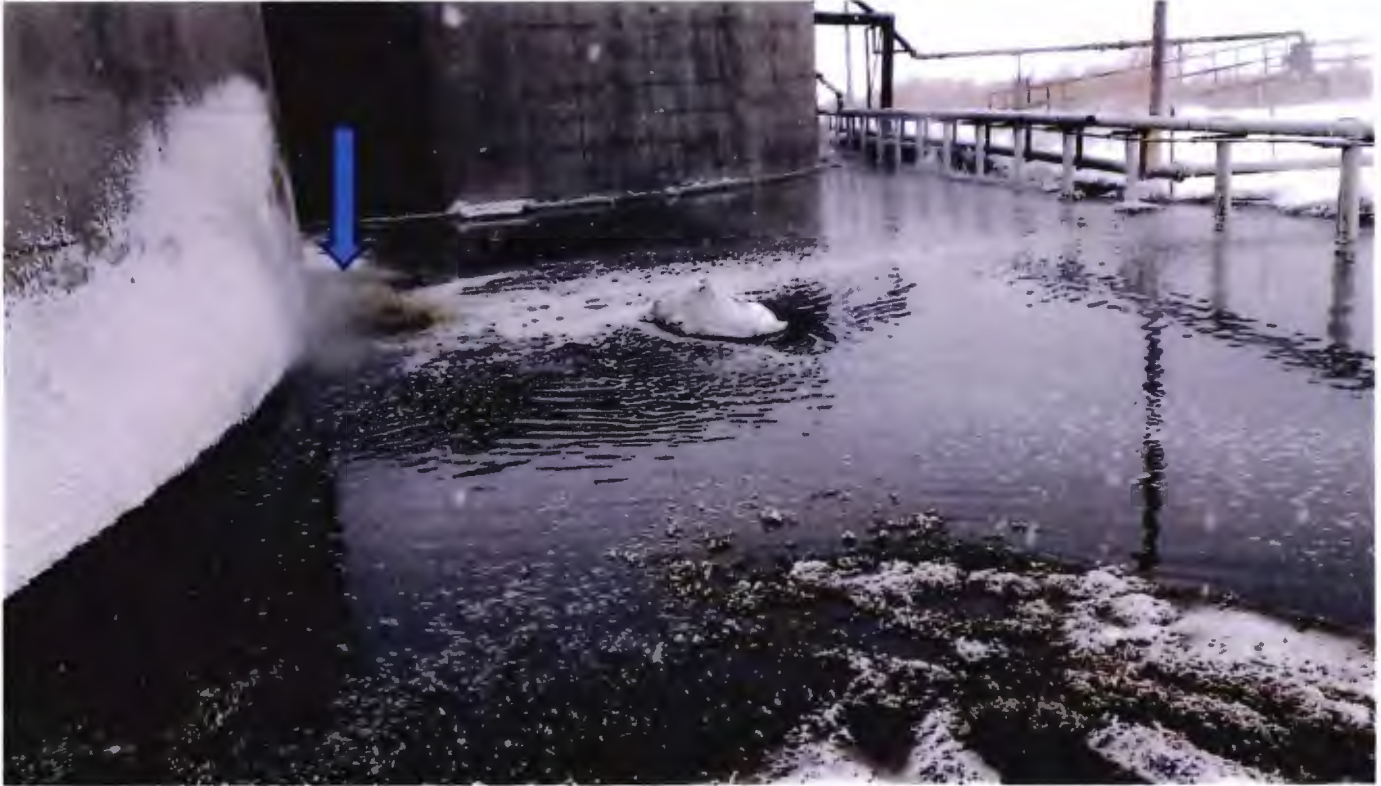
Photo 4

Description: This photo depicts the damaged area (arrow). Water is quickly exiting the digester creating ponding and discharge.

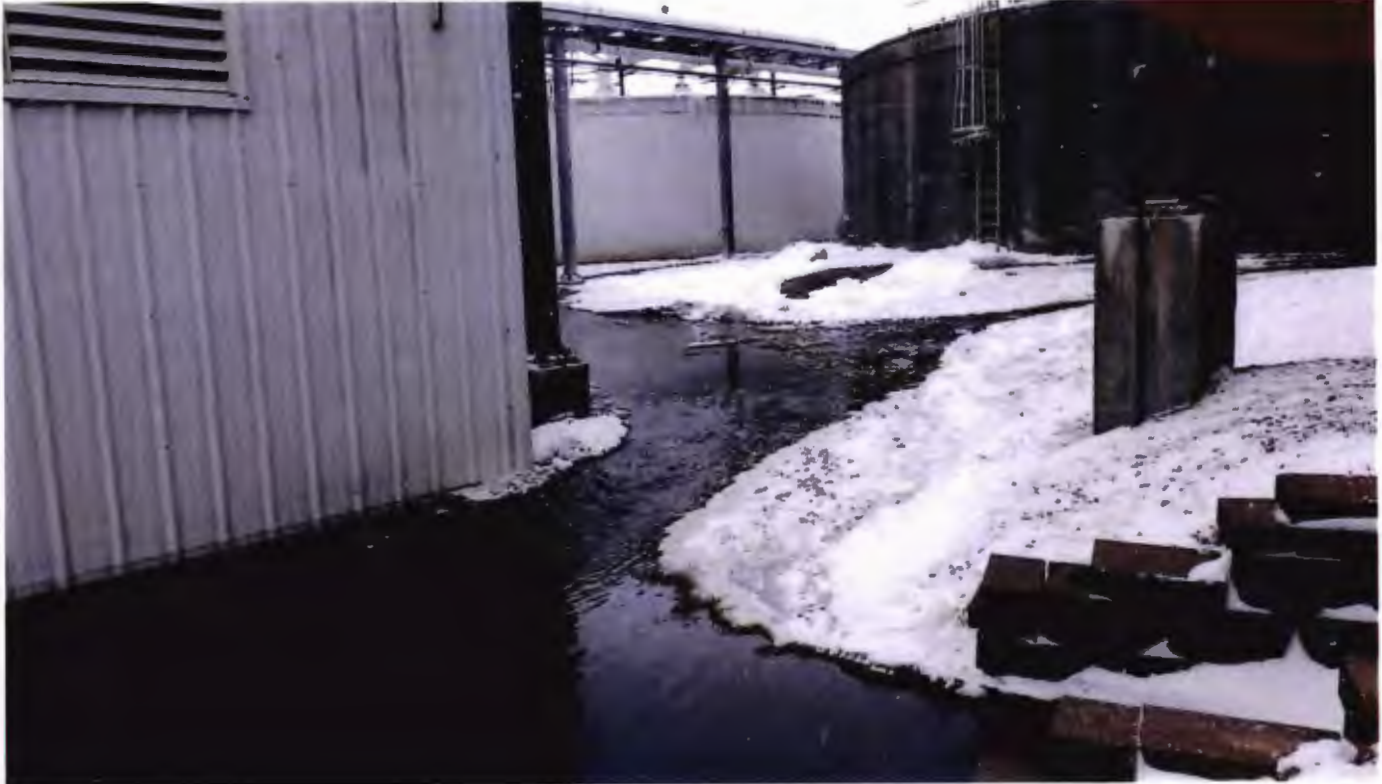
Photo 5

Description: This photo water flowing behind the digester. Wastewater is flowing behind the digester (arrow). Flow continued southwest and into the conveyance system depicted in photo 1.

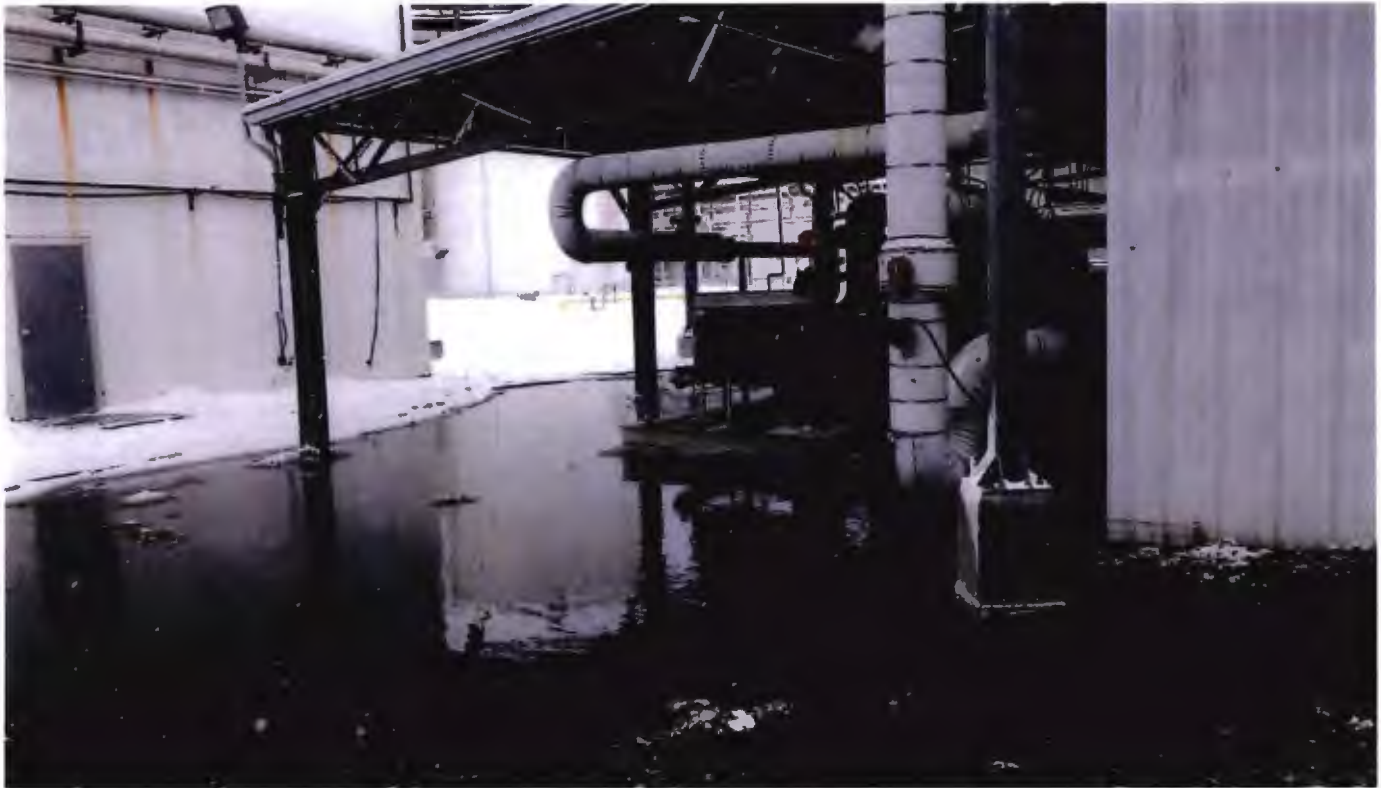
Photo 6

Description: This photo is pooled water west of the digester.

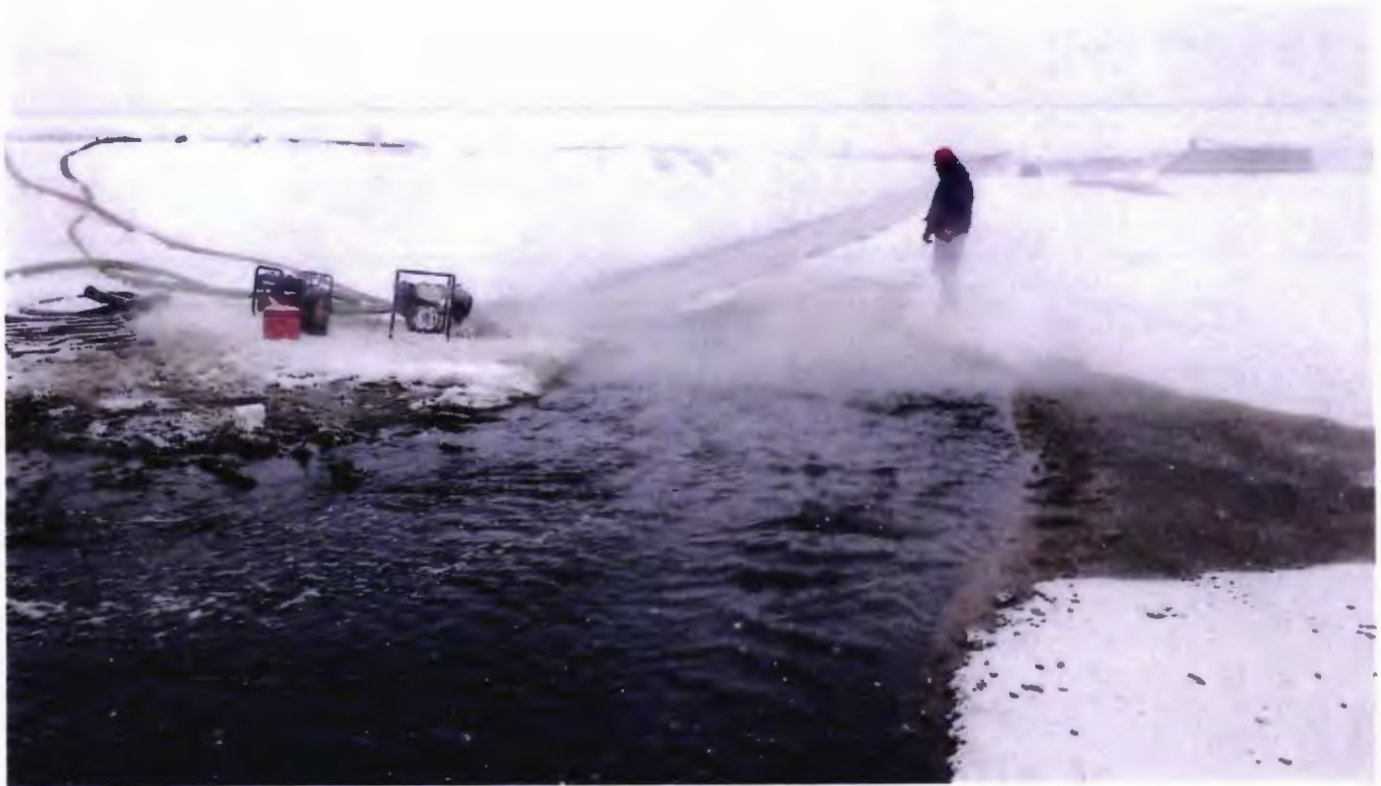
Photo 7

Description: This photo depicts the trash pumps used to transport water into the emergency lagoon.

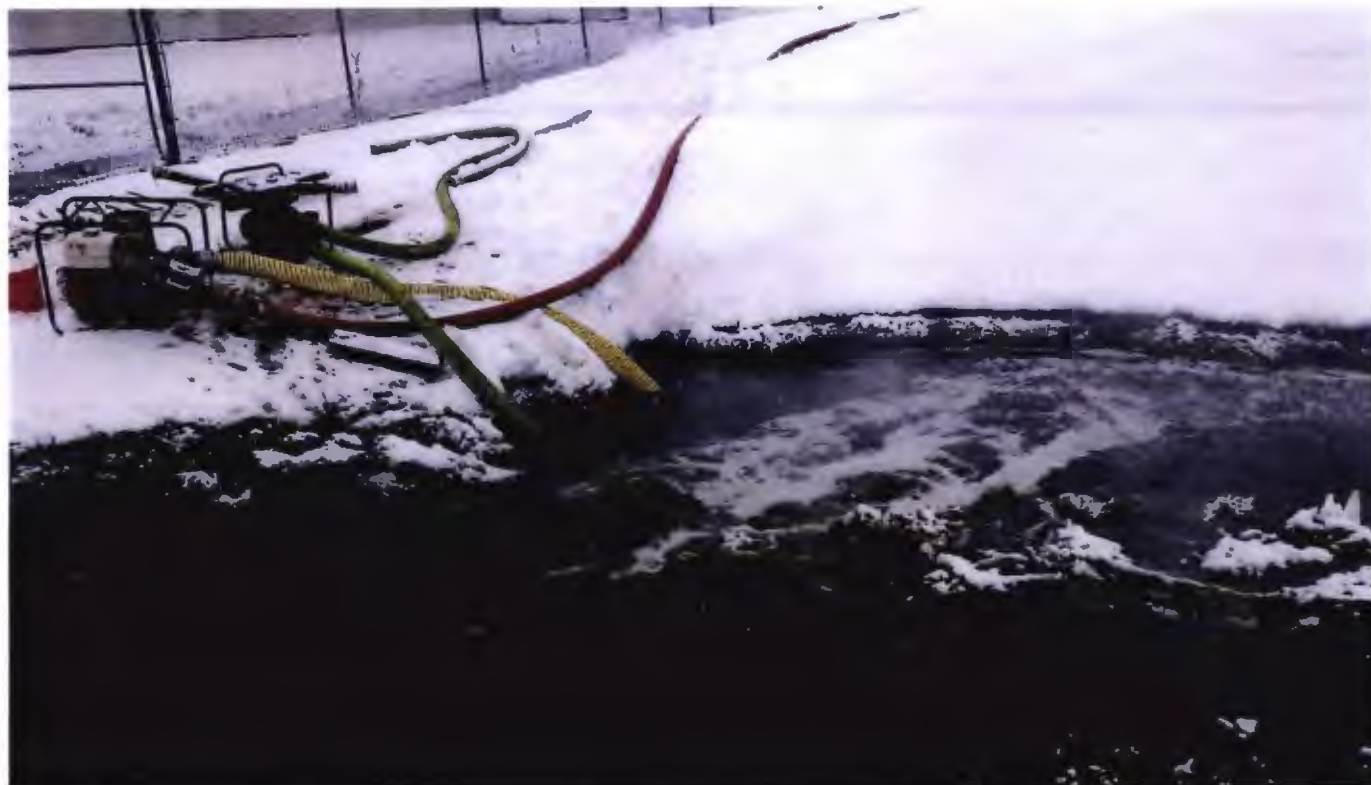
Photo 8

Description: This photo depicts the trash pumps used to transport water into the emergency lagoon.

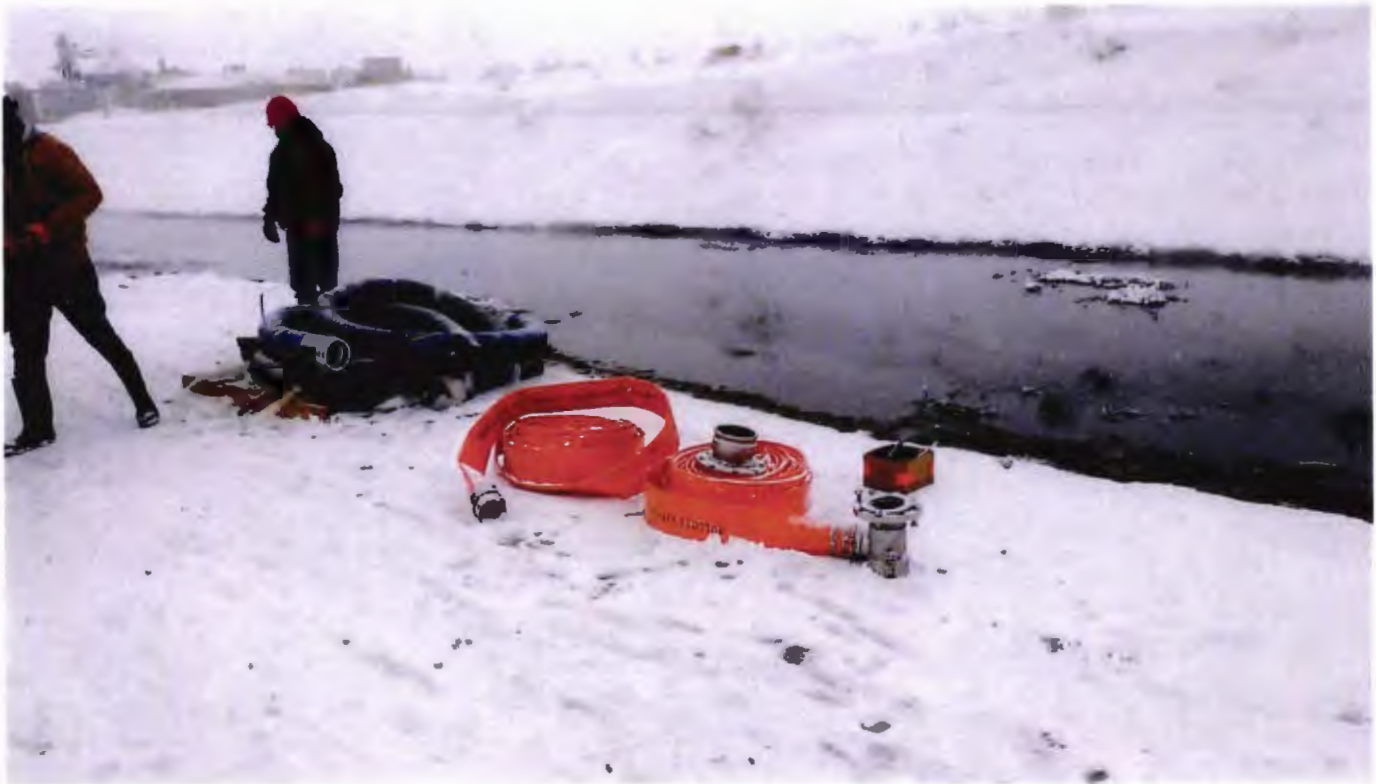
Photo 9

Description: This photo depicts AltEn personnel working to install an additional trash pump. The pump is being installed approximately 100 yards east of the pumps depicted in photo 8.

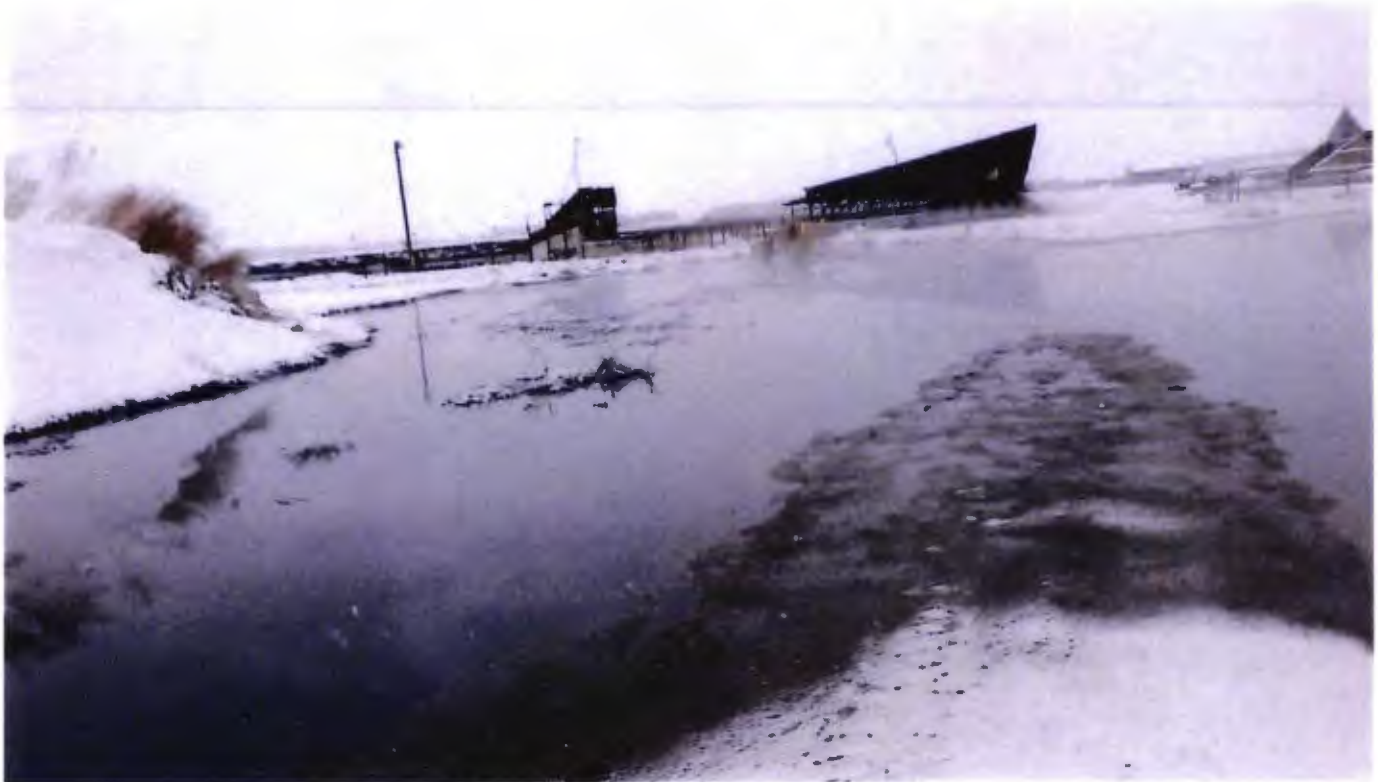
Photo 10

Description: This photo depicts the creek flooding the road entering Mead Cattle.

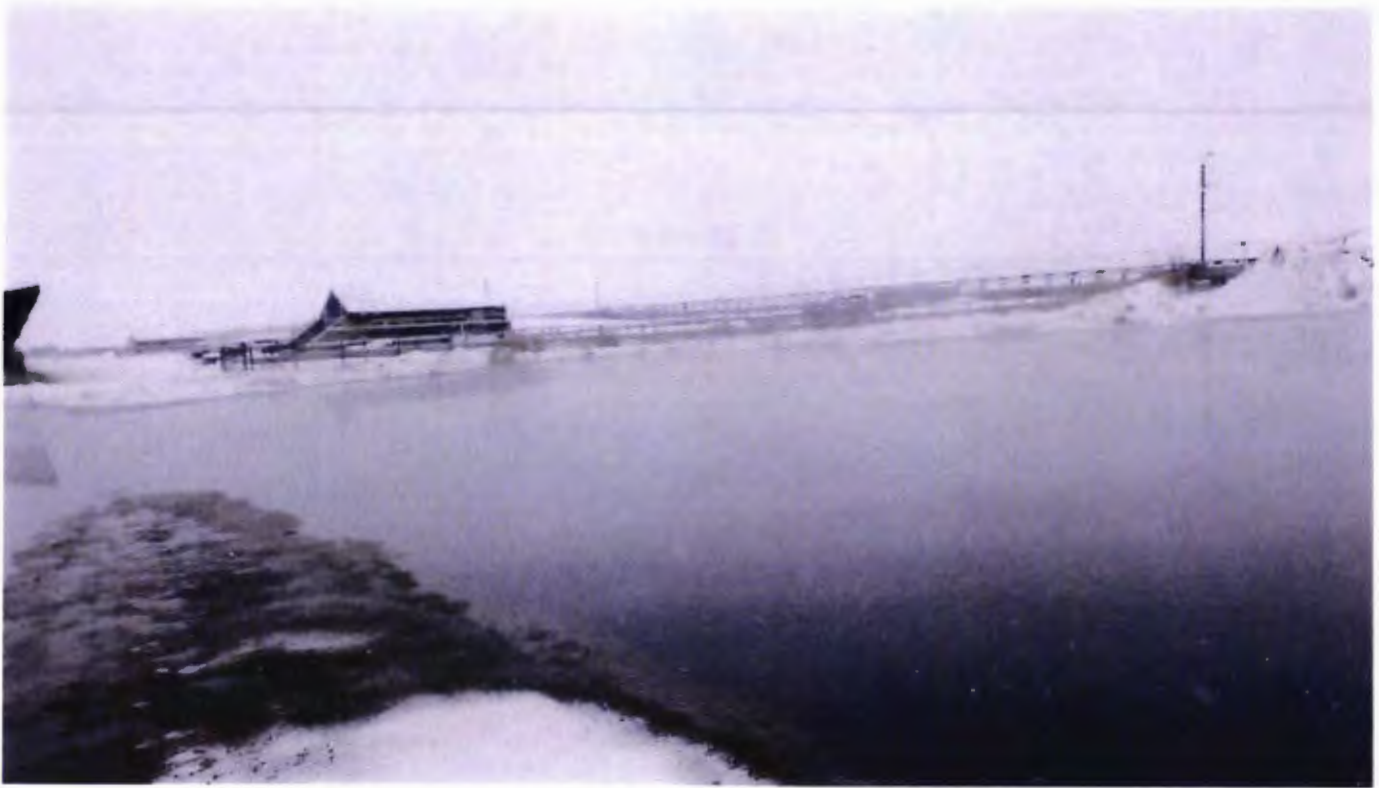
Photo 11

Description: This photo depicts water flooding the road and ponding on the south side.

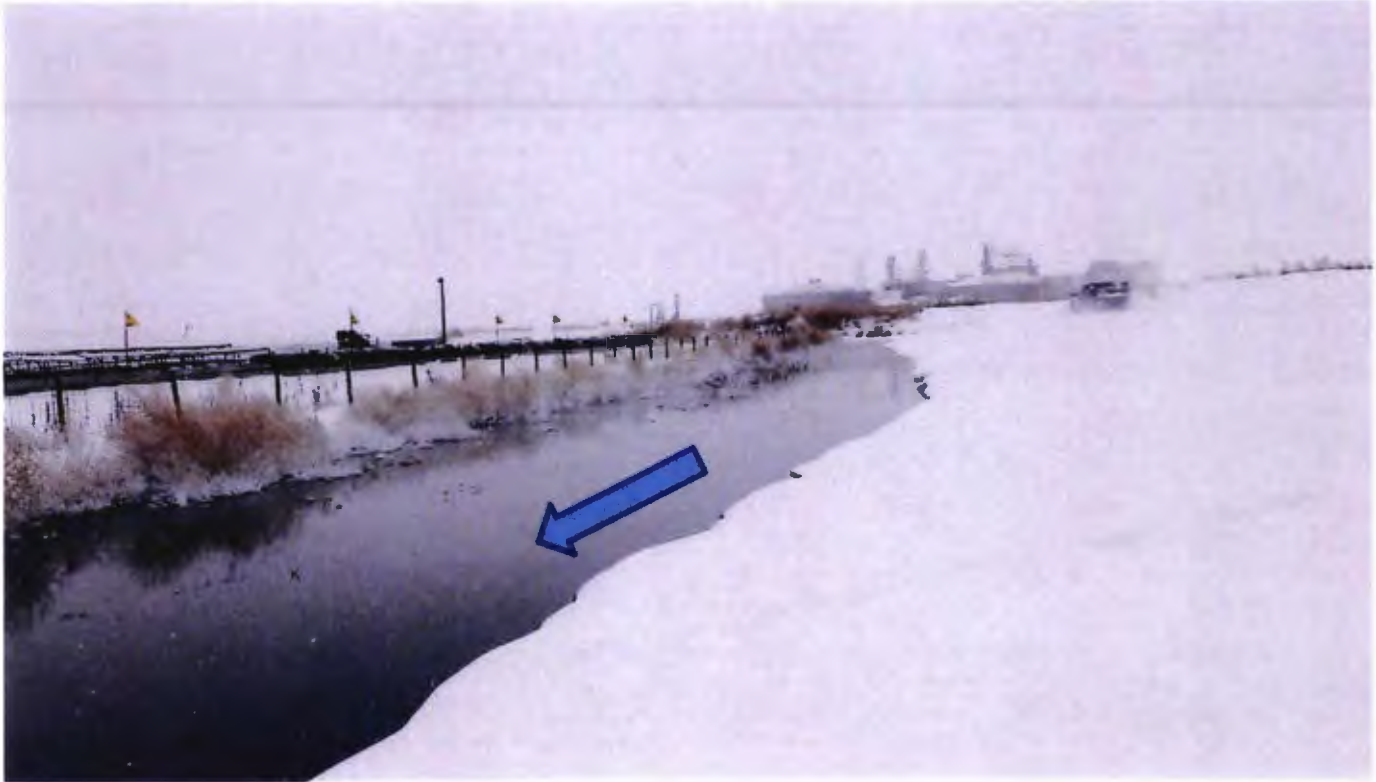
Photo 12

Description: This photo depicts wastewater flowing east along Mead Cattle. The arrow depicts flow direction.

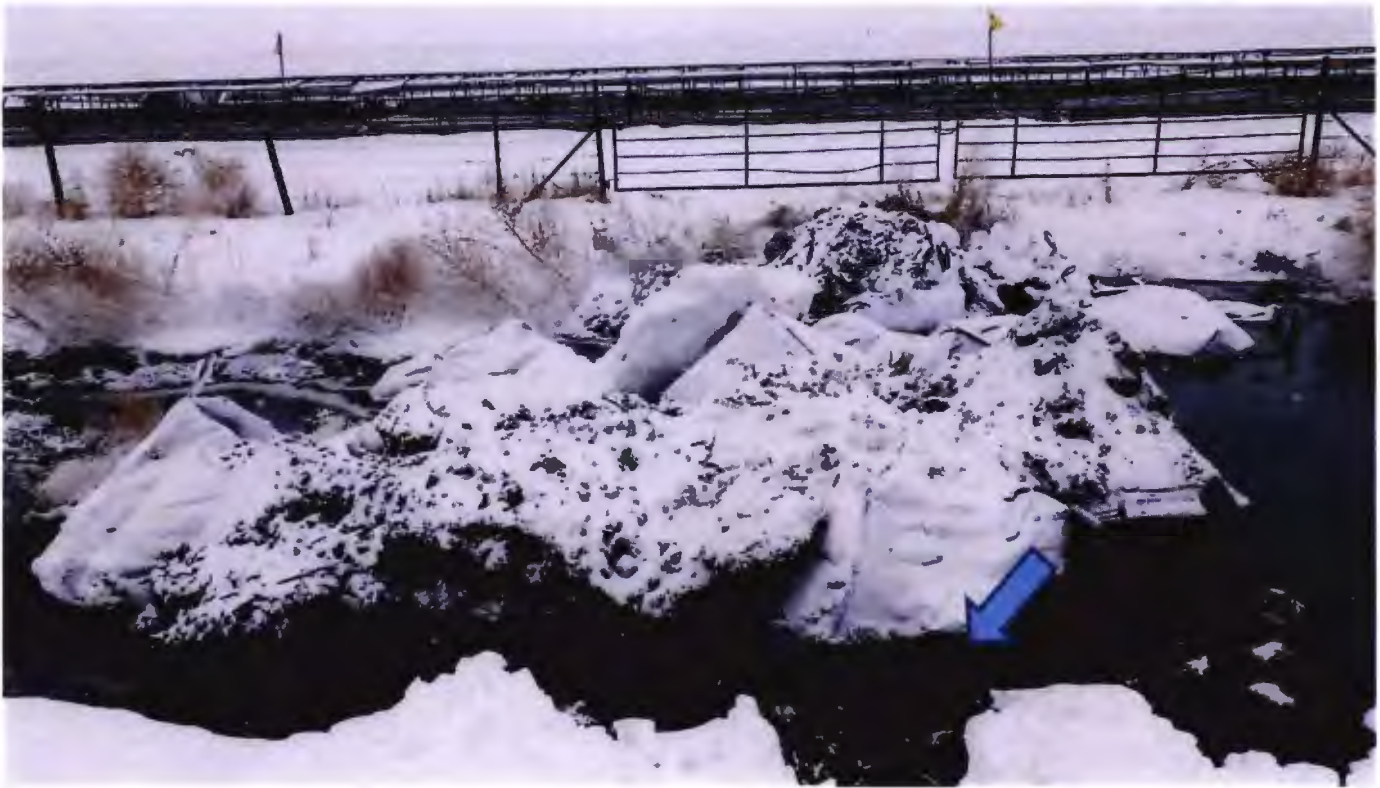
Photo 13

Description: This photo depicts a makeshift dam made of biochar supersacks. This photo also depicts the breach that occurred on the north side (arrow)

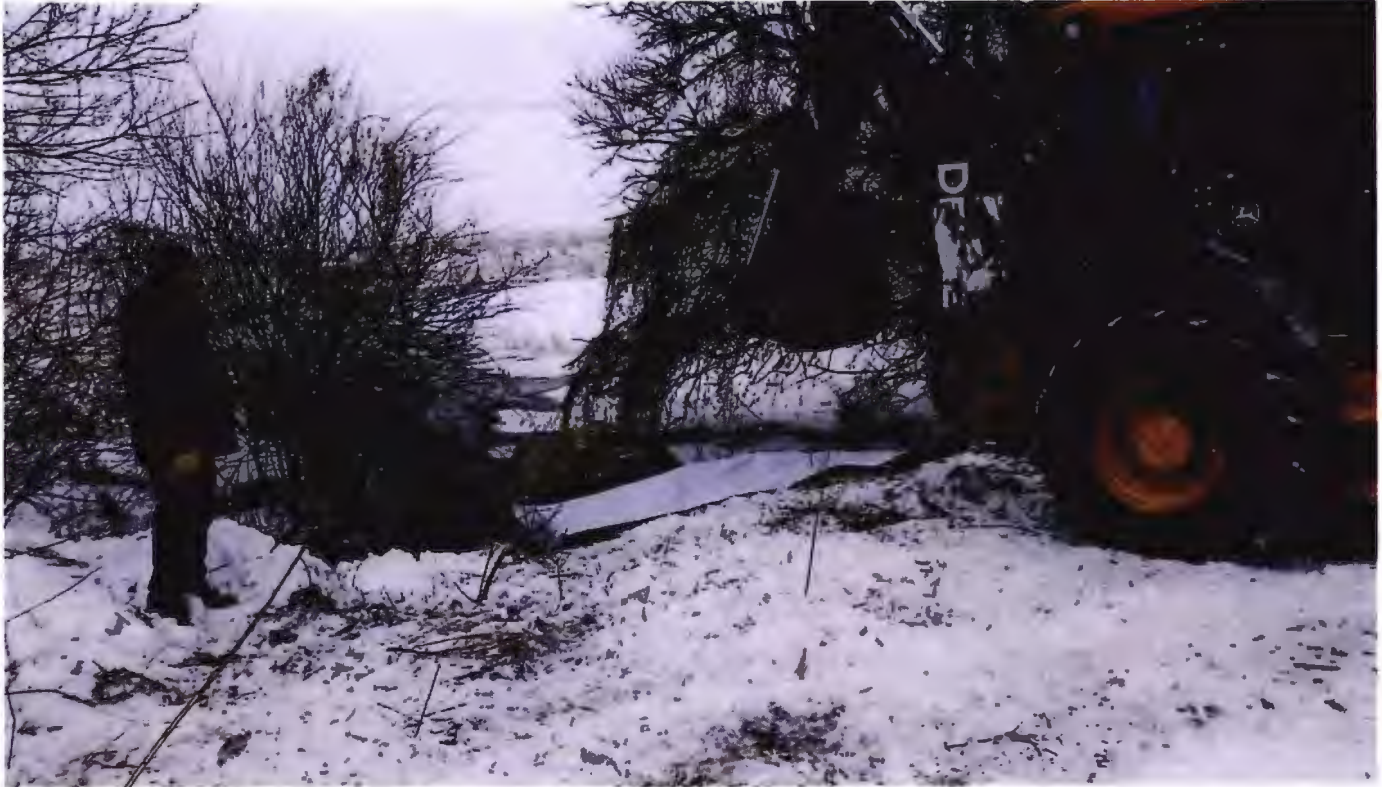
Photo 14

I then drove to the culvert that exits the facility. The culvert is located on the southeast side of the property. When I arrived, I met representatives from the University of Nebraska – Lincoln (UNL). I observed UNL installing plastic, bales and cement (rip-rap) in attempt to hold back the flow, photos 14 and 15.

Description: This photo depicts UNL personal installing plastic and bales to dam the culvert.

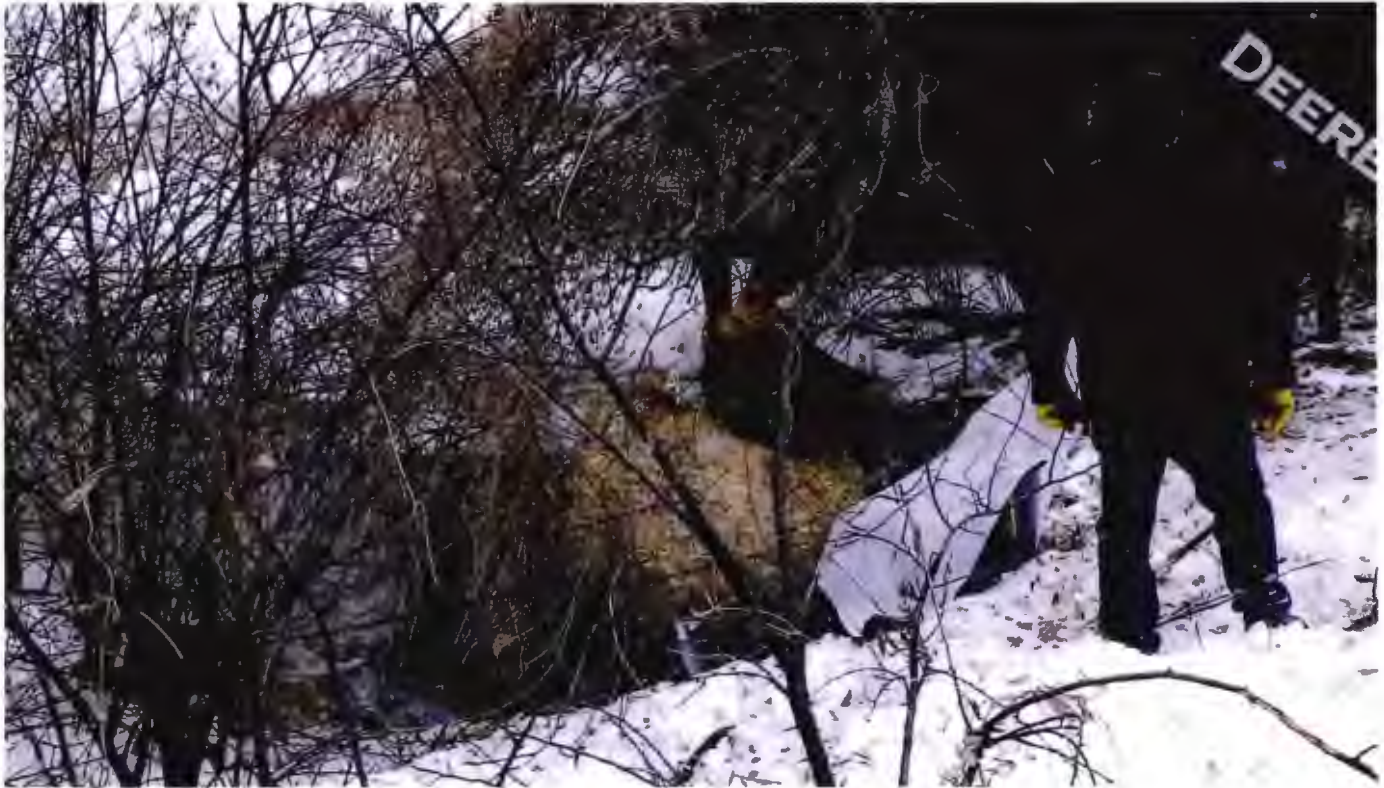
Photo 15

Description: This photo depicts UNL using a backhoe to push a bale and plastic into place.

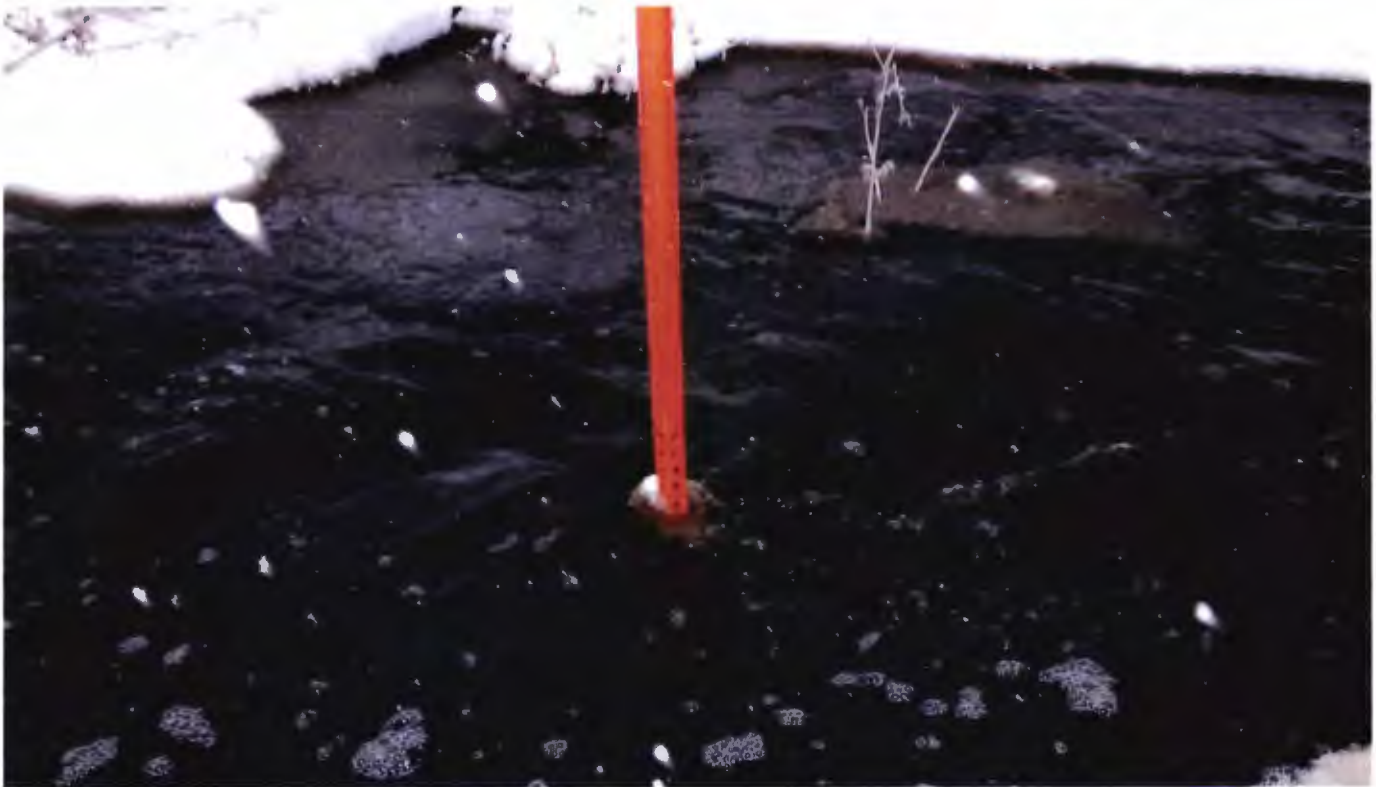
Photo 16

Description: This photo depicts UNL property adjacent county road 9. This photo is a depth finder that UNL installed to measure flow. Mr. Brummel (UNL) stated that water depth had been rising 2 inches per hour.

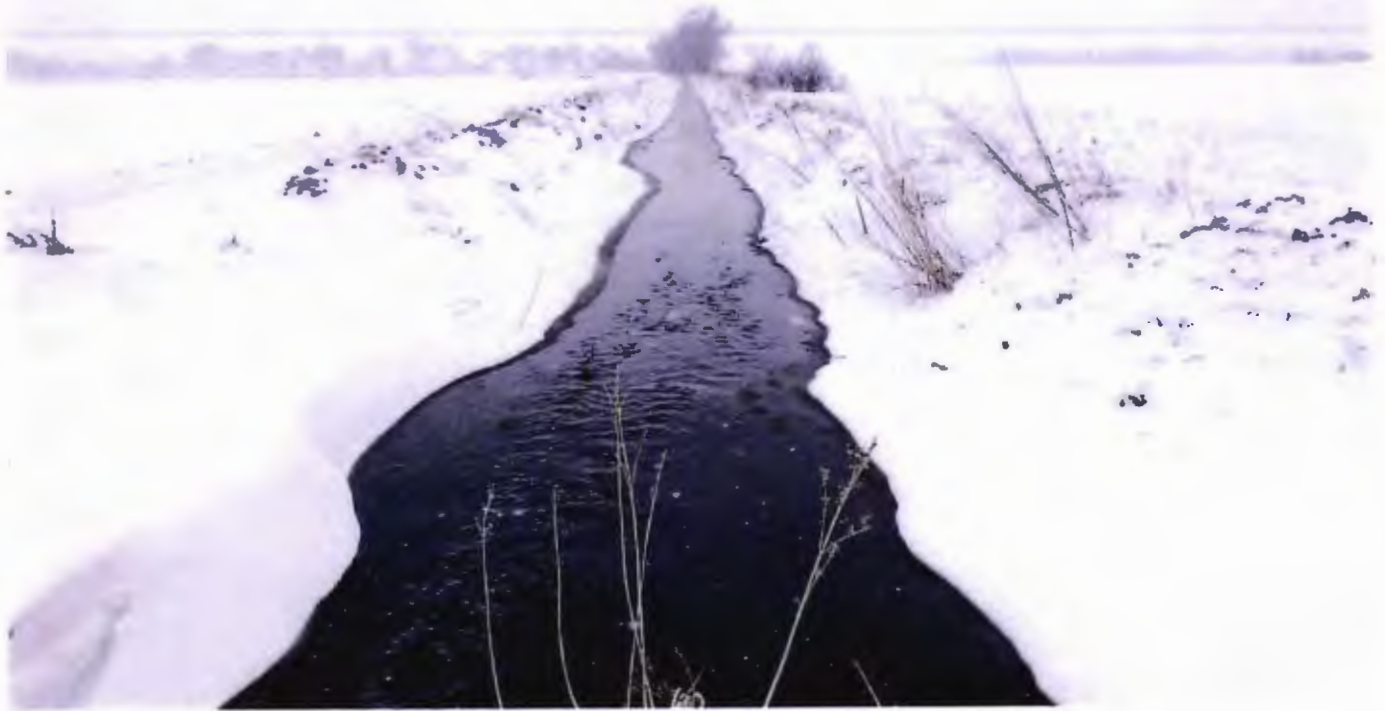
Photo 17

The flow continued through the culvert and then entered UNL property. Prior to investigating UNL property, I met with Sheldon Brummel (UNL). Mr. Brummel agreed to escort me to various locations to document flow. Mr. Brummel provide access to the first culvert site. I observed dark colored water and odor near a depth finder. Mr. Brummel stated that they have sampled the location all day and the depth has steadily increased, photo 16. I took photos from this area documenting the flow and dark colored water, photo 17.

Description: This photo is from the same area as the above photo. This photo is facing south from onto the culvert. I observed dark water and odor at this location.

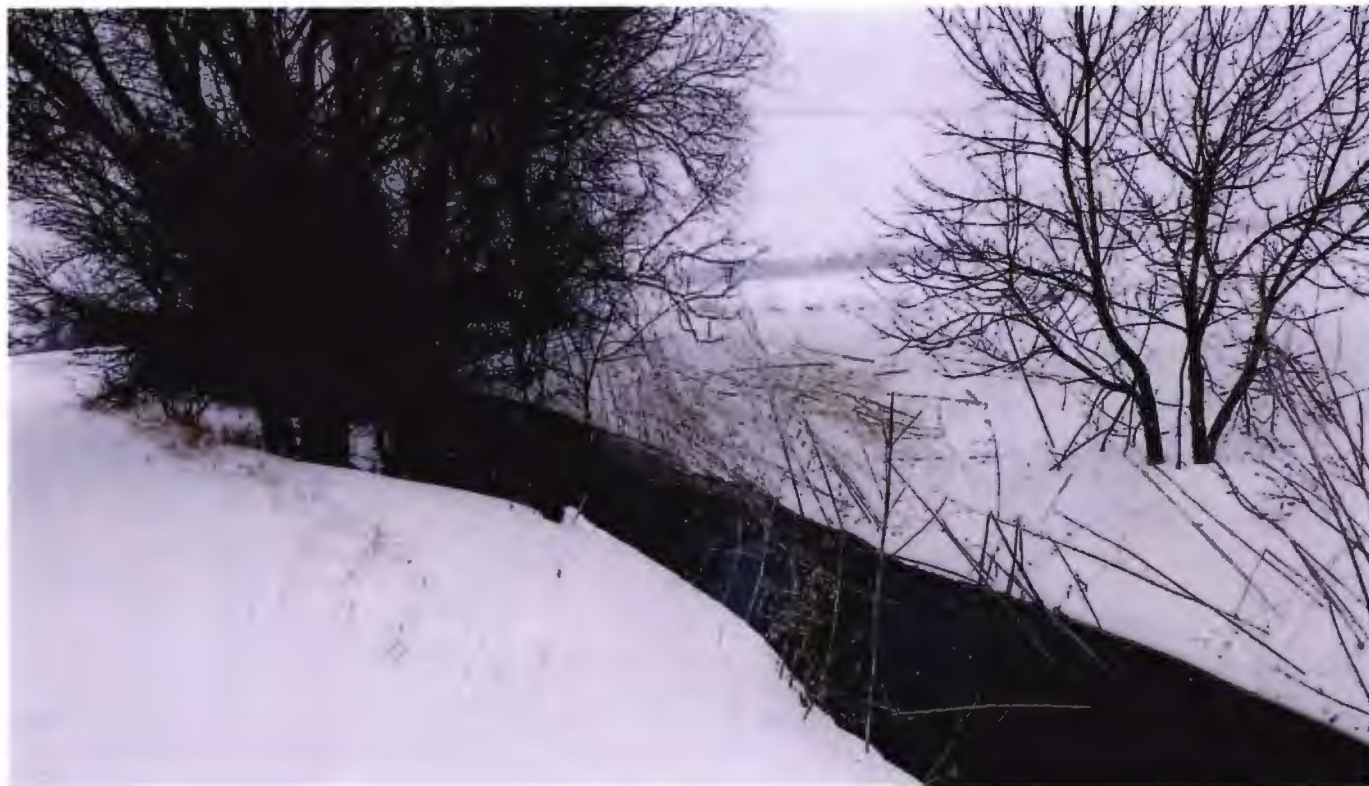
Photo 18

Mr. Brummel drove farther downstream. I again observed flow, dark colored water and noted odor, photo 18.

Description: This photo depicts an area deep into UNL property. I observed flow, dark water and odor.

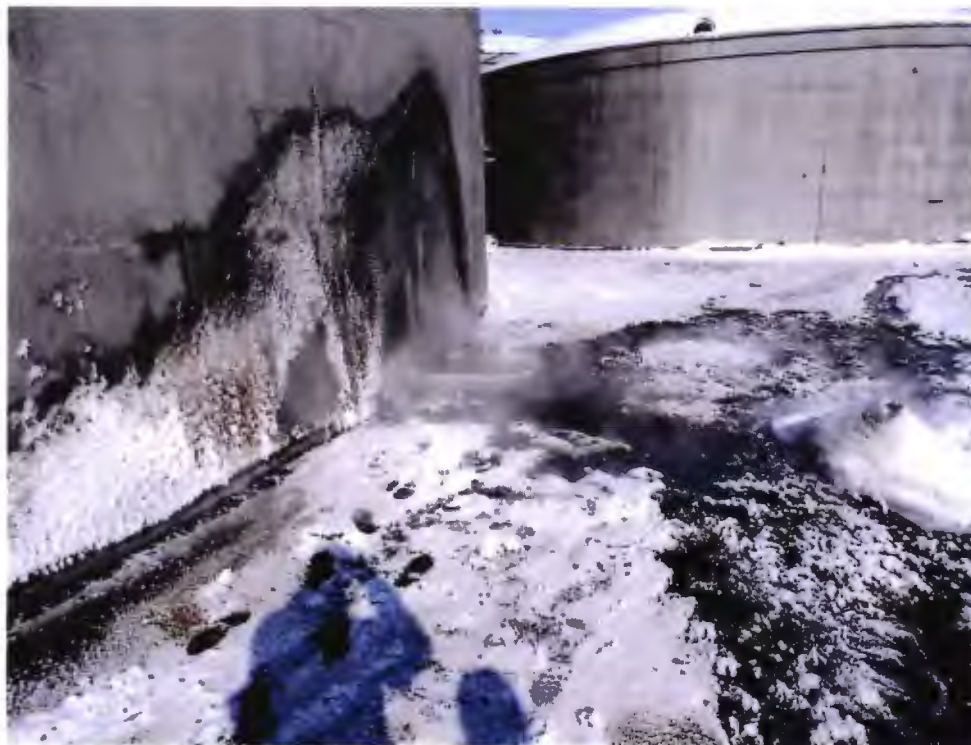
A digester containing thin stillage and cattle manure suffered a catastrophic failure due to a pipe connected to the floor of the digester bursting; reportedly due to freezing weather. An estimated

View north of piping vault where leak occurred

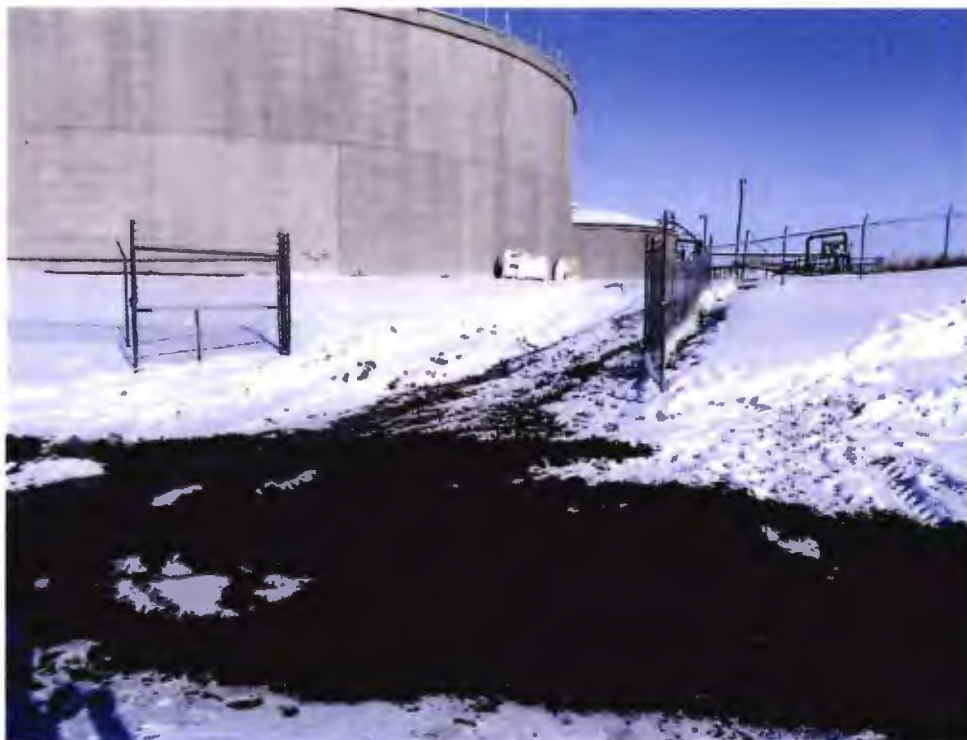
View north of digester where leak occurred

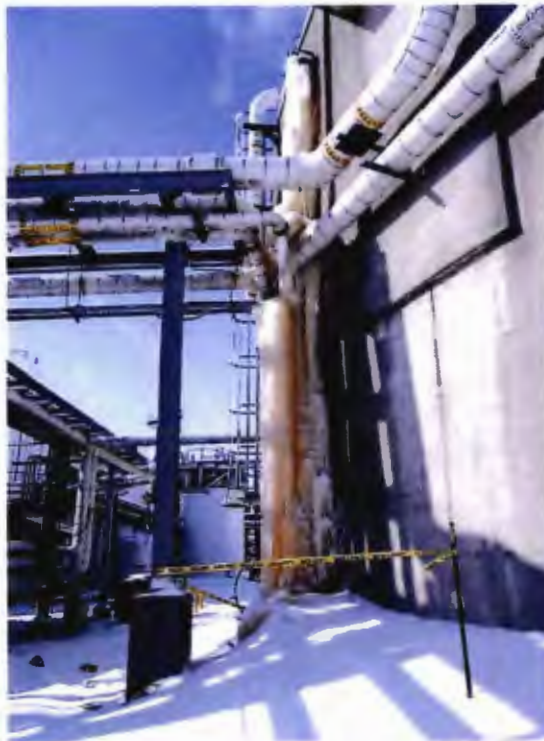
Spilling and leaking liquid from digester without leak

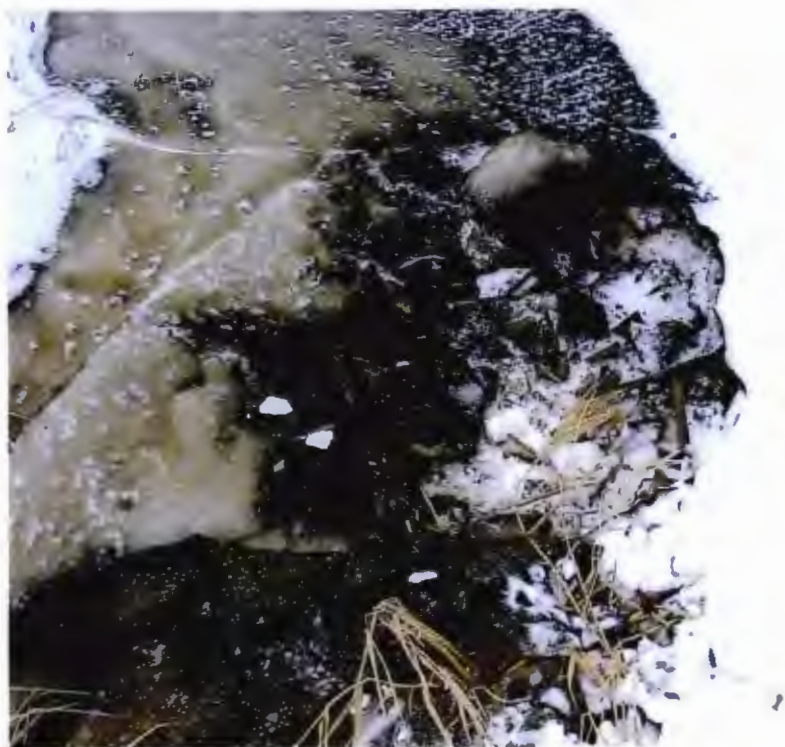
Broken crust of ice at culvert inlet at Stop #4
