BEFORE THE NEBRASKA DEPARTMENT OF ENVIRONMENT AND ENERGY

IN THE MATTER OF)	
AltEn, LLC,)	CASE NO. 3546
)	
FID # 84069)	EMERGENCY COMPLAINT
)	AND ORDER
Respondent.)

Release of Thin Stillage and Cattle Manure from Digester at AltEn LLC, IIS #84069, RA
#021221-NH-0845

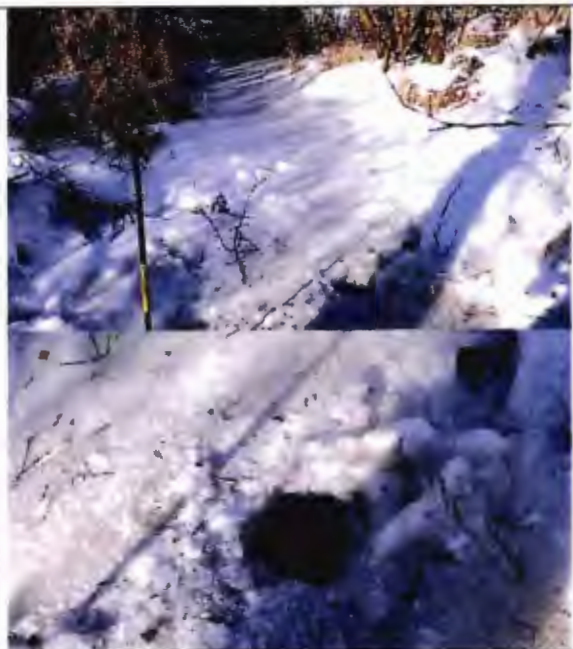
STOP 3 – Road 7/Highway 66

I found no evidence of the AltEn LLC thin stillage discharge reaching this location. I chopped a hole in the ice (~12 inches thick) to the channel's substrate. It was completely frozen, with no water below the ice. Photos were taken looking west/northwest (upstream).

The berm/dam located here made up of a tarp and sand bags appears to have constructed on top of the channel's ice surface in front the culvert. It would seem prudent to chip the ice away and lower the entire structure.

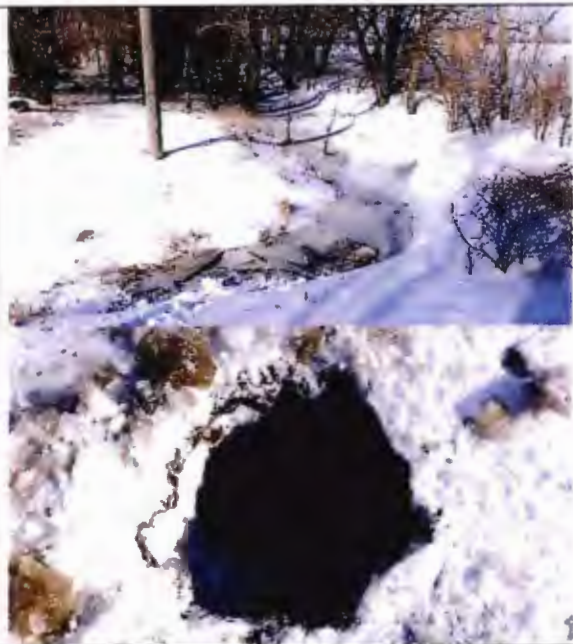
STOP 4 – County Road 8, North of Road H

The AltEn LLC thin stillage discharge water remains as a frozen layer on top of the original ice layer that existed prior to the thin stillage release. The frozen waste water ice is much darker in appearance than the snow and original ice in the channel. The darker, frozen top layer was easily broken by walking on it. I did chop a hole through the channel's original ice layer (~12 inches thick) and found water underneath at this location. I do not believe the water to be the thin stillage waste, as there was no pressure from below that filled the hole I had opened. However, I did not have a meter with me to confirm to be true.

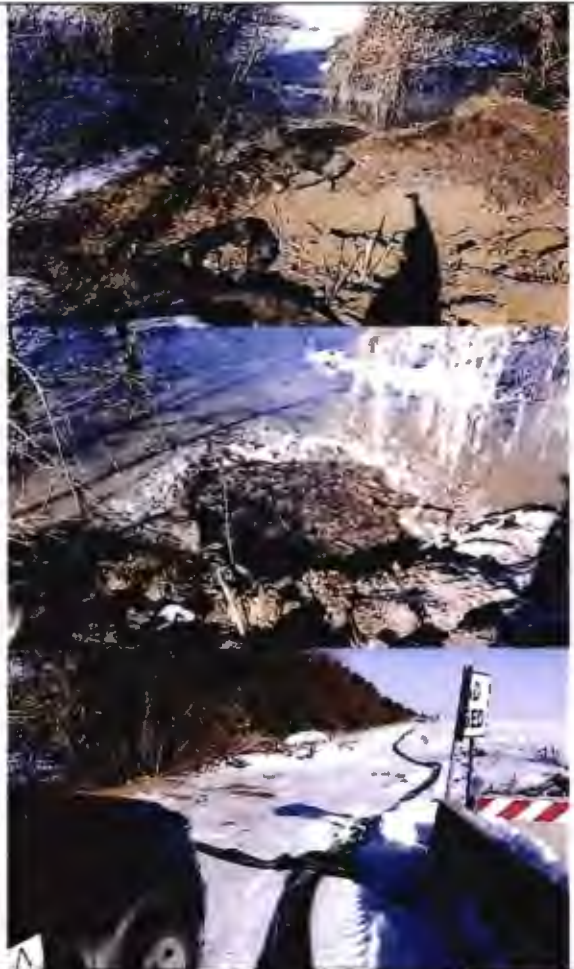
STOP 5 – UN-L Eastern Extension – North of County Roads 9 & J

The AltEn LLC thin stillage discharge water remains as a large pooled area behind the make-shift dam constructed on the upstream (west) side at this location. Ken Peterson (AltEn Plant Manager) showed up while I was at this location. He told me they had placed additional earthen material here to stop the seepage through the culverts. He also said they planned to start pumping the liquid from this location back into a lagoon yet today. A hose was stretched out in this area, but no pump was in place when I was there.

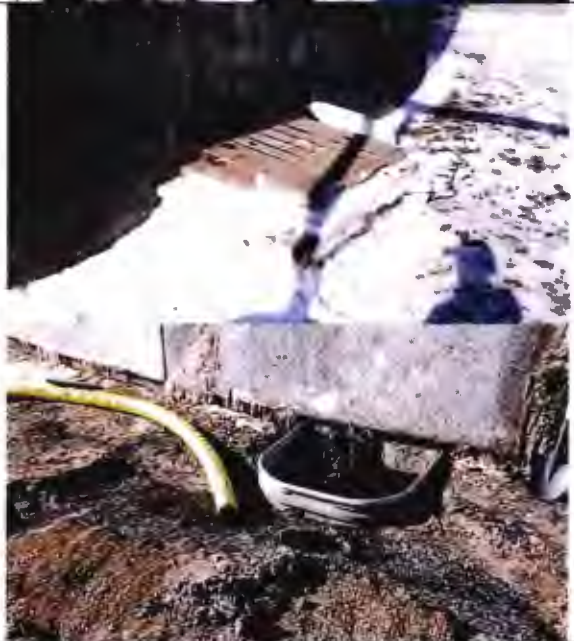
STOP 6 – ALTEN LLC FACILITY DIGESTERS

Ken Peterson (AltEn Plant Manager) led me to the digesters and gave me a quick tour. I did not observe any discharges from either the north or south stillage tank. The top photo is the covered pipe/valve housing on the north tank and the bottom photo is of the one that failed on the south tank.
