BEFORE THE NEBRASKA DEPARTMENT OF ENVIRONMENT AND ENERGY

IN THE MATTER OF)	
AltEn, LLC,)	CASE NO. 3546
)	
FID # 84069)	EMERGENCY COMPLAINT
)	AND ORDER
Respondent.)

Release of Thin Stillage and Cattle Manure from Digester at AltEn LLC, IIS #84069, RA
#021221-NH-0845

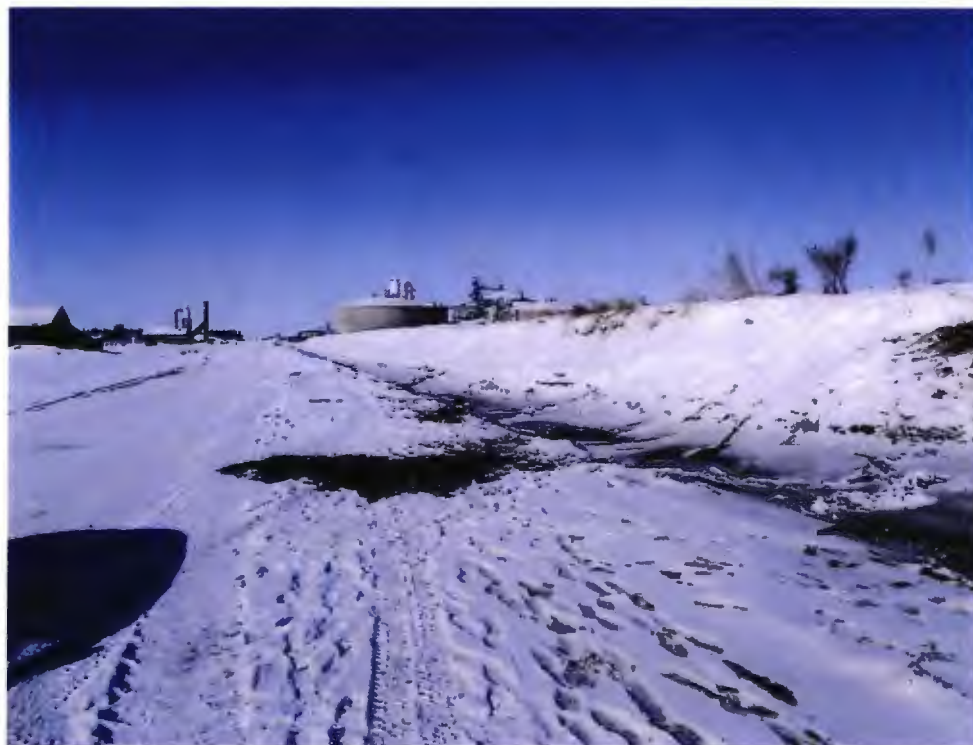
View west of road ditch with digester in background

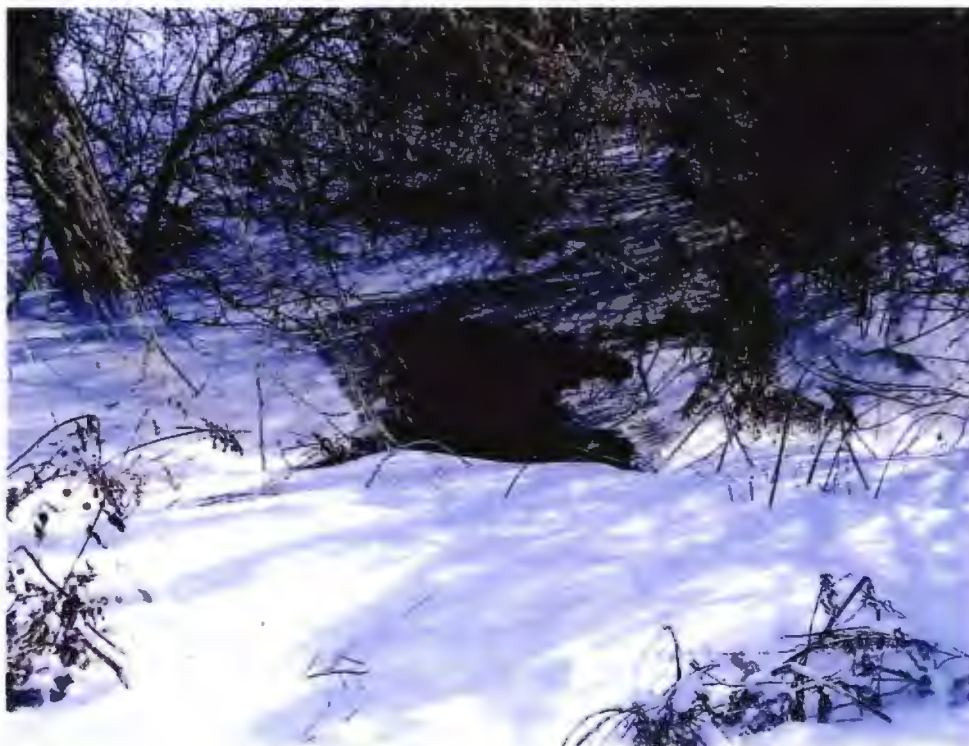
View east of ditch downstream from culvert A

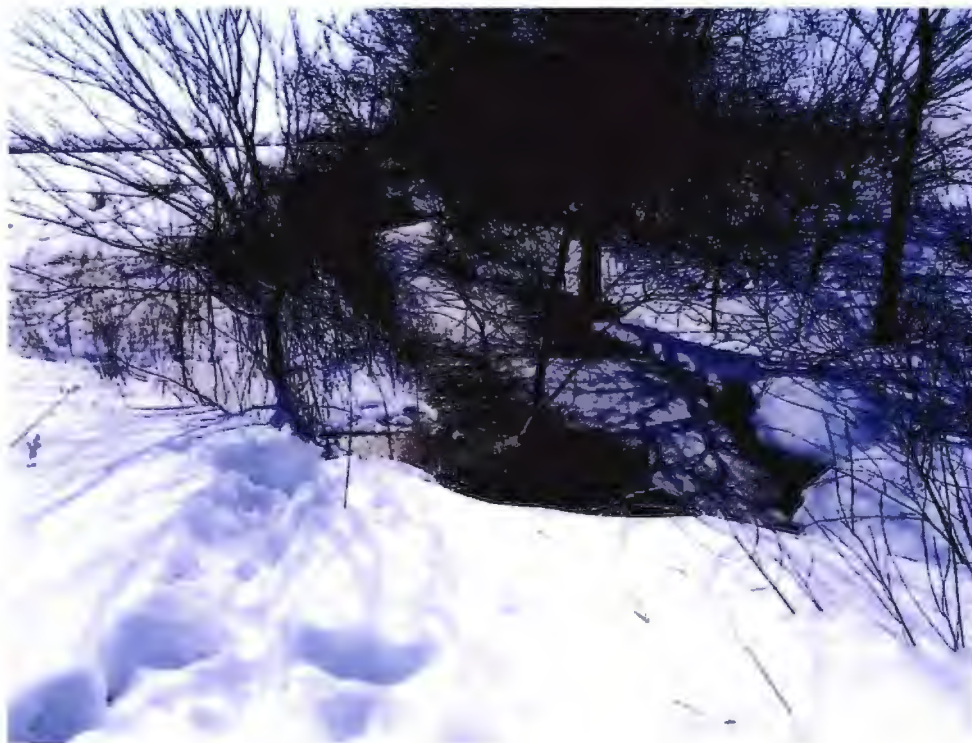
Mark and I proceeded to the next downstream location, depicted as culvert B on the attached Google Earth image, where the ditch intersected with a roadway. We observed liquid flowing through the culvert (see attached photos). Based upon the cold temperatures that we presume would have frozen any pre-existing water and the odor associated with the flowing liquid we observed, that the flowing liquid was likely what had spilled from the digester.

View north of ditch upstream from culvert B

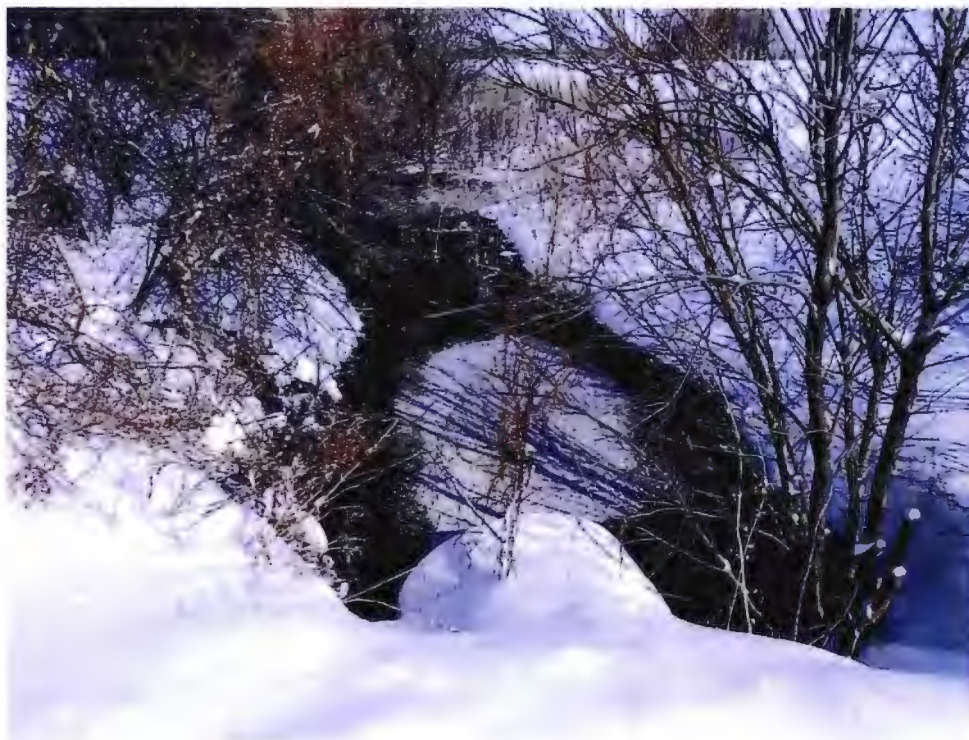
View south of ditch downstream of culvert B

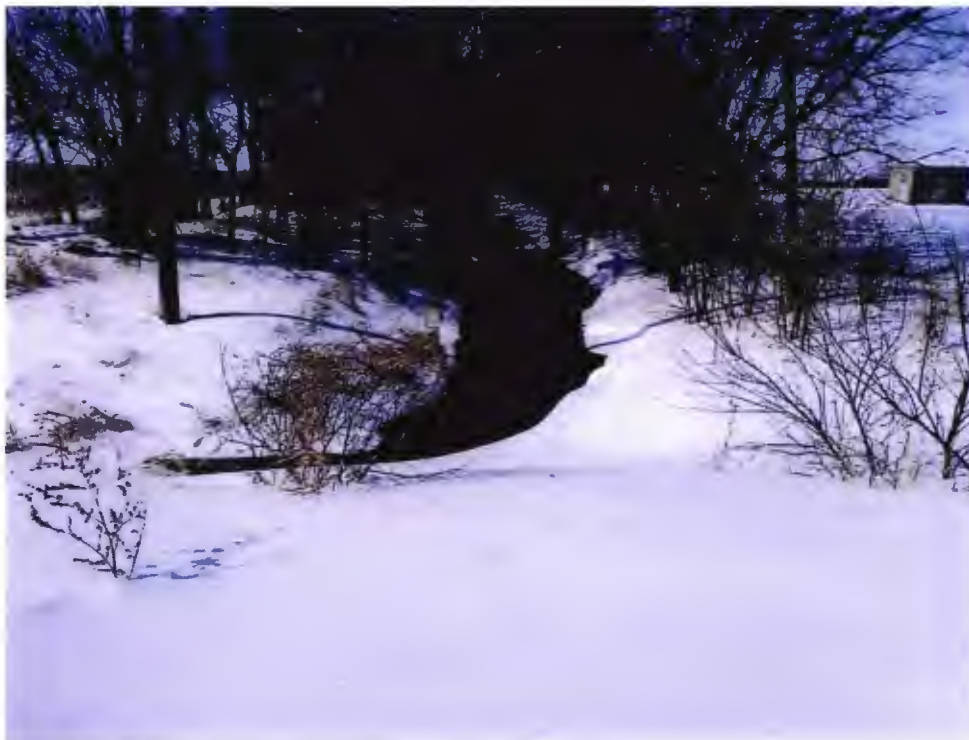
Mark and I proceeded to the location depicted as culvert C on the attached Google Earth image. We observed liquid flowing through the culvert (see attached photos). We proceeded to the location depicted as culvert D on the attached Google Earth image. We observed an inch or two of liquid on top of existing ice and within the snow cover (see attached photos). There was no obvious flow of this liquid. The liquid did exhibit an odor similar to the liquid spilled from the digester.

View north of ditch upstream from culvert C

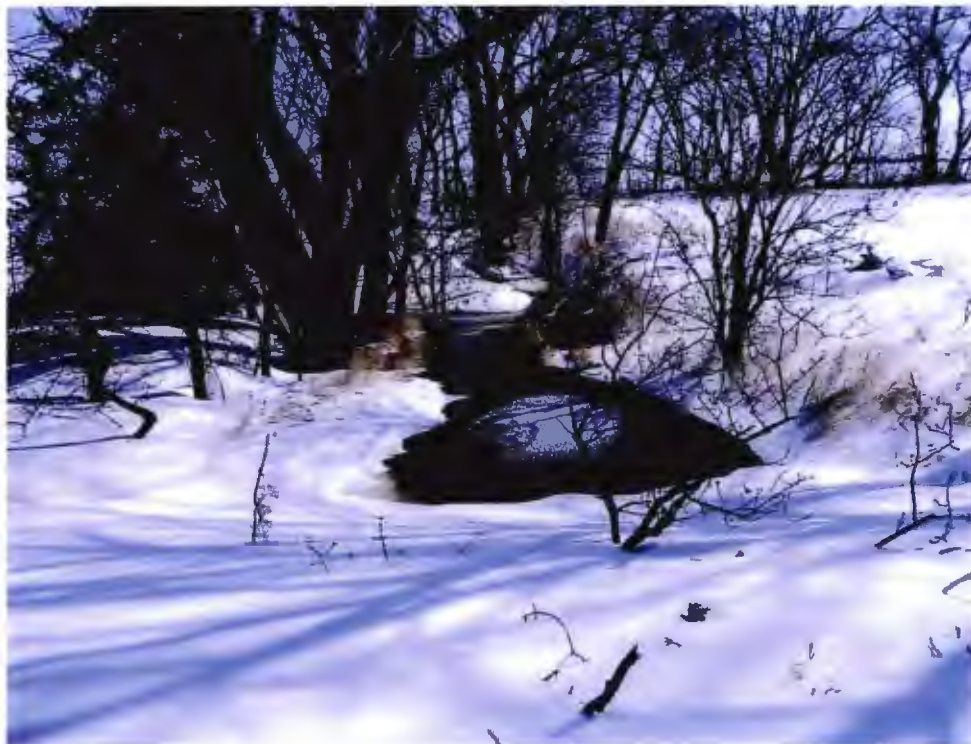
View south of ditch downstream from culvert C

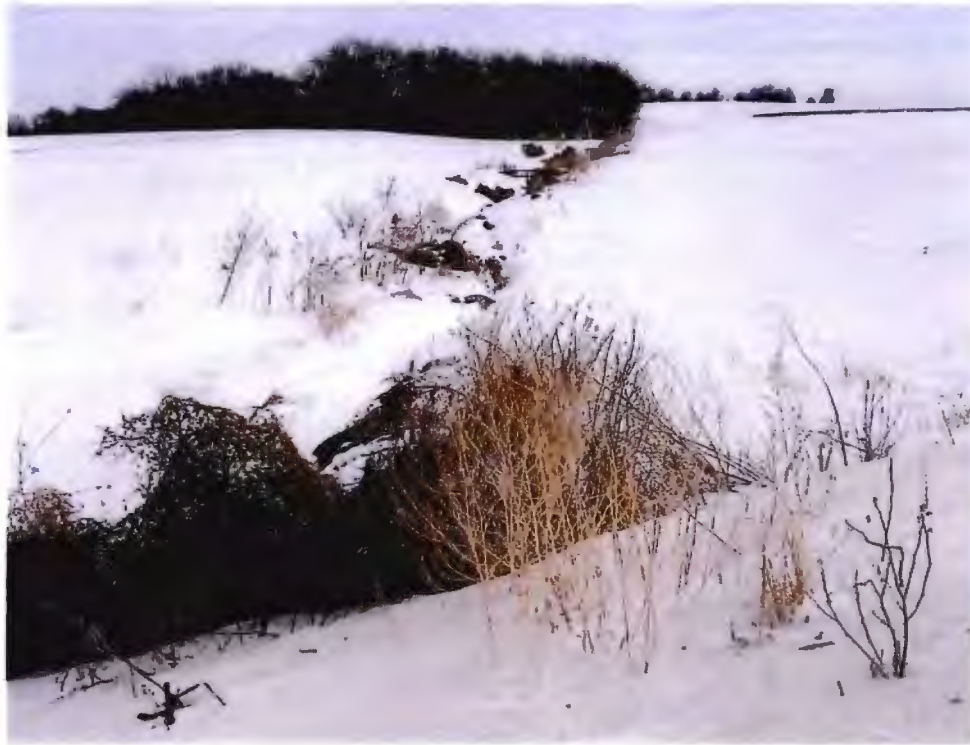
View east of ditch downstream from Stop #2

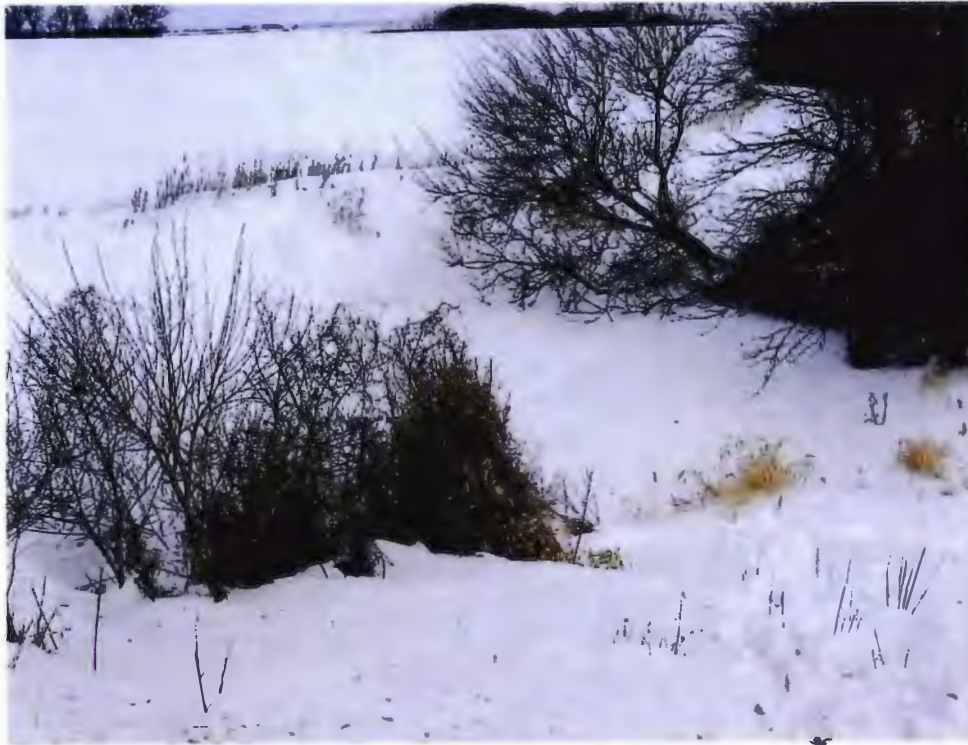
View east of ditch downstream from Stop #3

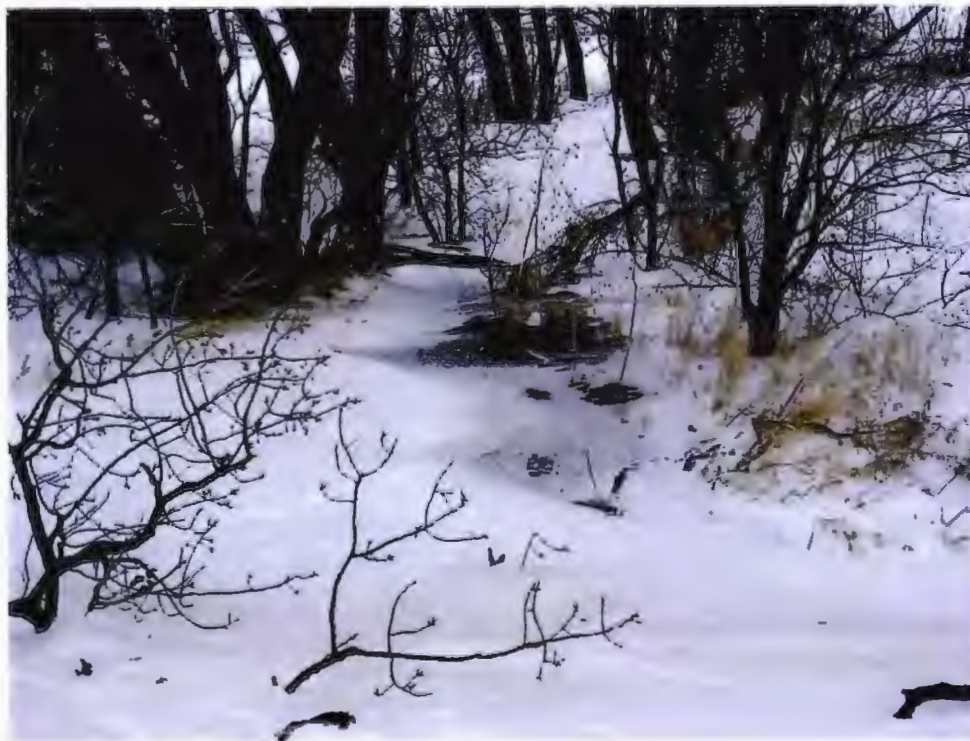
I proceeded to Stop #4. Stop #4 is located on road 8 about 1/2 mile north of road H. I observed brown-colored ice both upstream and downstream from Stop #4. Upstream from Stop #4, the ice was broken in many pieces as if it froze and the liquid below drained away (see attached photos).

View east of ditch downstream from Stop #4

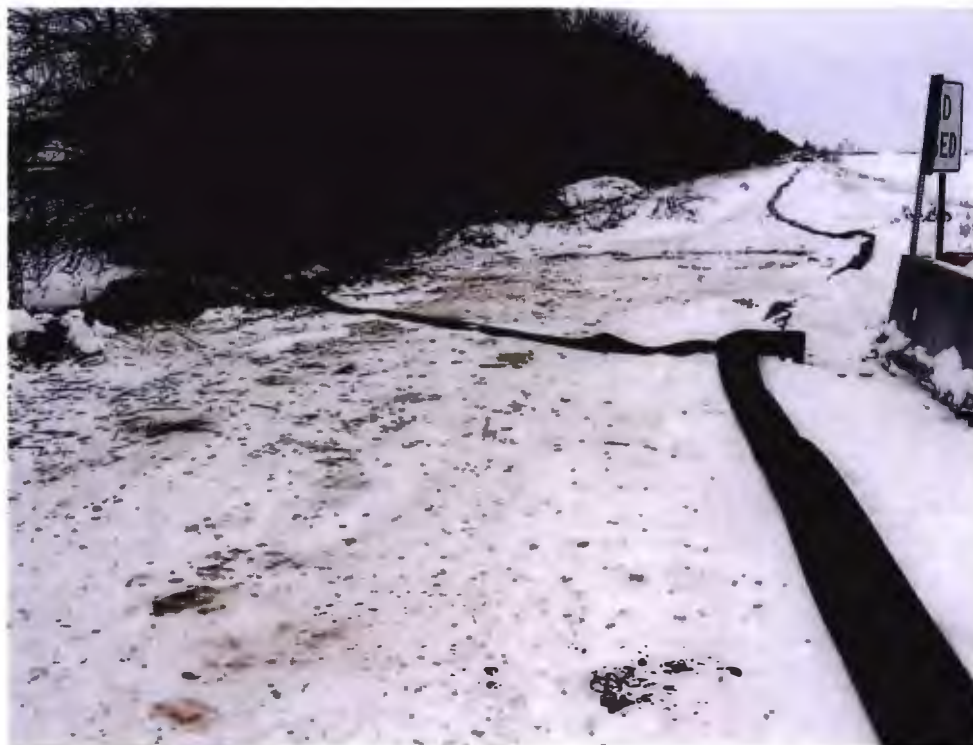
View north of piping laid out at Stop #5
