BEFORE THE NEBRASKA DEPARTMENT OF ENVIRONMENT AND ENERGY

IN THE MATTER OF)	
AltEn, LLC,)	CASE NO. 3546
)	
FID # 84069)	EMERGENCY COMPLAINT
)	AND ORDER
Respondent.)

Release of Thin Stillage and Cattle Manure from Digester at AltEn LLC, IIS #84069, RA
#021221-NH-0845

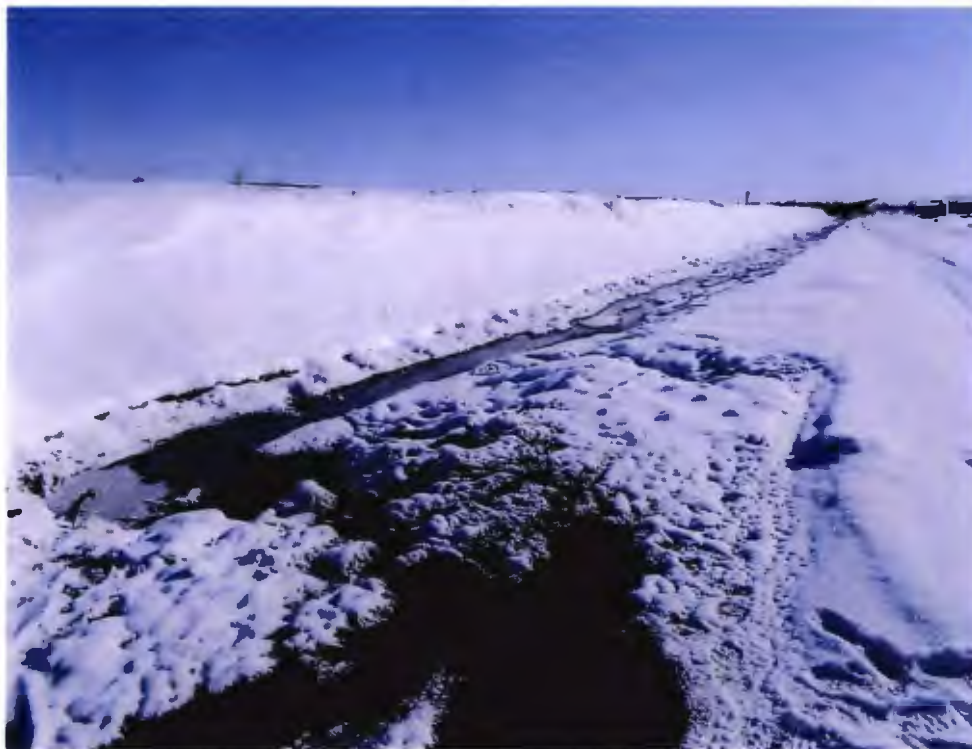
View east from near digester toward road ditch

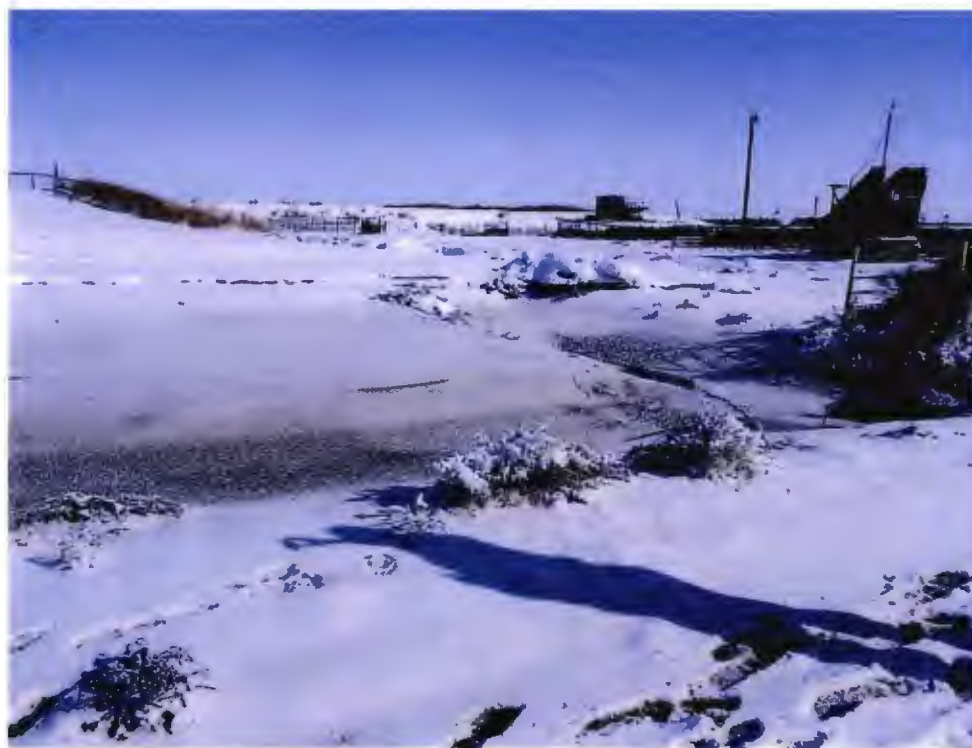
View NE of ditch near Mead Cattle Company

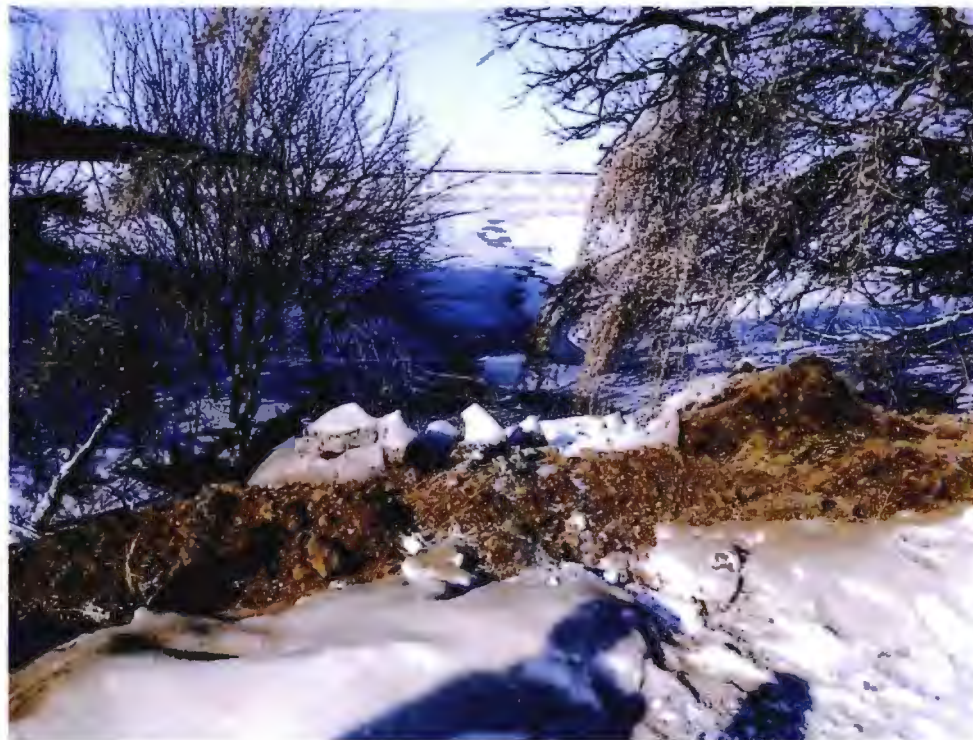
four million gallons of liquid was released to the land surface. The spilled liquid flowed into a ditch and travelled approximately three miles from the source at the time of our response. A dam constructed some time Friday, was ineffective at stopping the flow of spilled liquid. It is not known if the lack of effectiveness of the dam was due to poor construction or failure of the dam due to build-up of hydrostatic pressure.

View WNW of dam upstream of culvert A

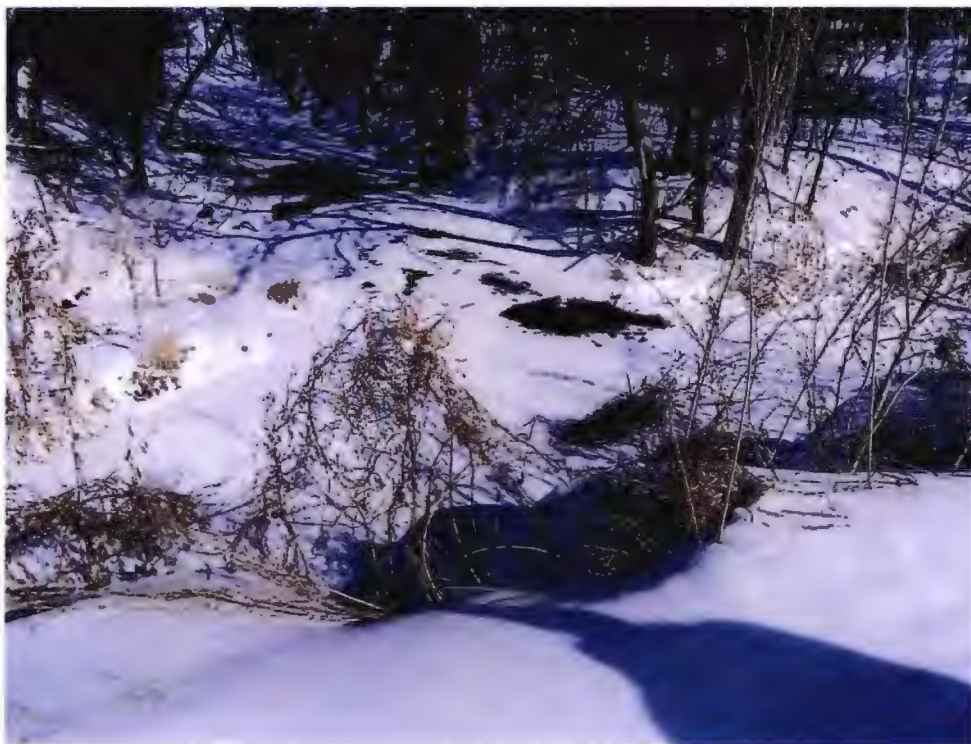
Mark and I proceeded to the location depicted as culvert C on the attached Google Earth image. We observed liquid flowing through the culvert (see attached photos). We proceeded to the location depicted as culvert D on the attached Google Earth image. We observed an inch or two of liquid on top of existing ice and within the snow cover (see attached photos). There was no obvious flow of this liquid. The liquid did exhibit an odor similar to the liquid spilled from the digester.

View north of ditch upstream from culvert D

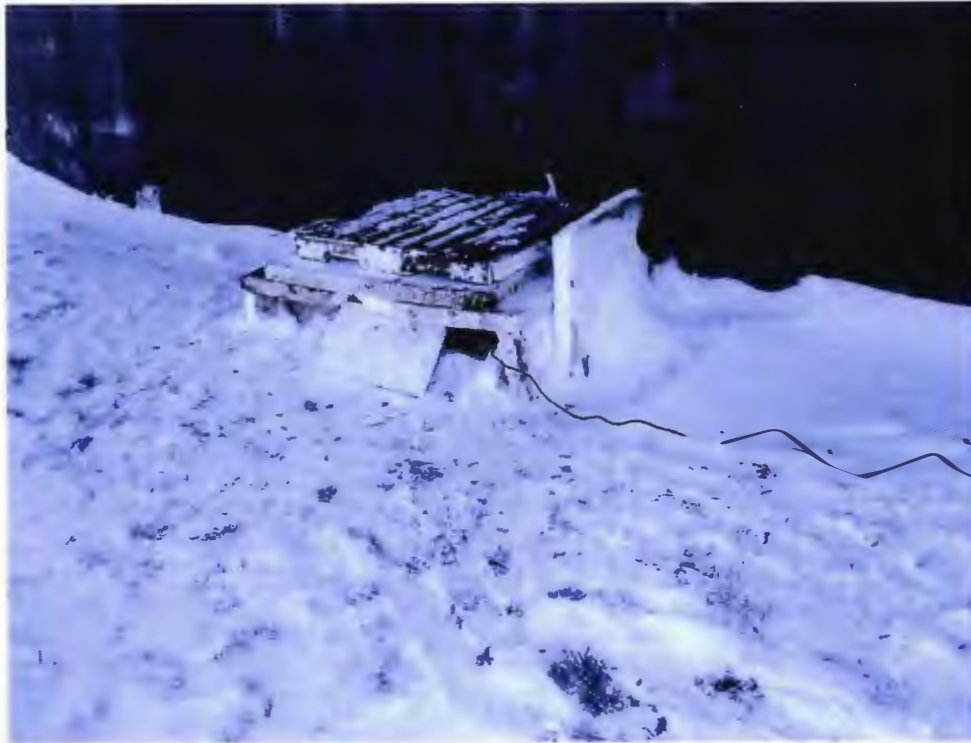
We returned to the AltEn facility to examine the digester that had not suffered a release. We observed a pile of Styrofoam insulation panels we presumed were covering the piping vault (see attached photo). We observed electrical wiring leading under the pile of insulation and presumed that to be for the heat lamp mentioned by Mr. Egr. We observed on the south side of the digester that had not suffered a leak a column of ice surrounded by caution tape (see attached photo). We could see a fitting above the column of ice actively releasing a liquid (which appeared to be freezing and creating the column of ice). We presumed this liquid was thin stillage and manure being released from the full or nearly full digester.

Insulation over piping vault on digester without leak

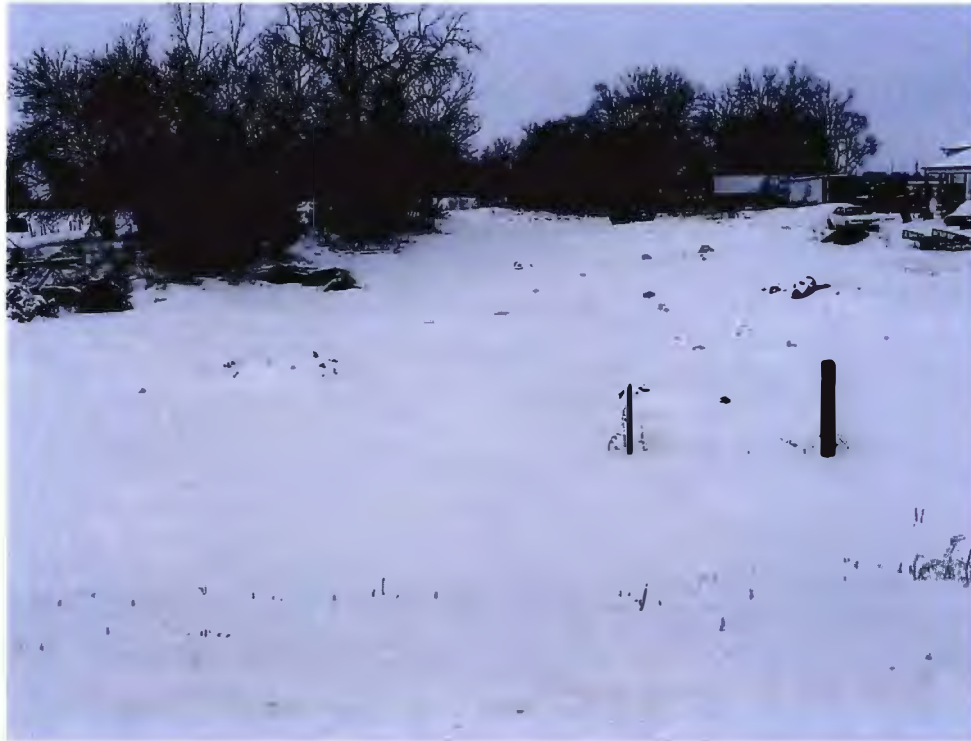
View north of ditch upstream from Stop #1

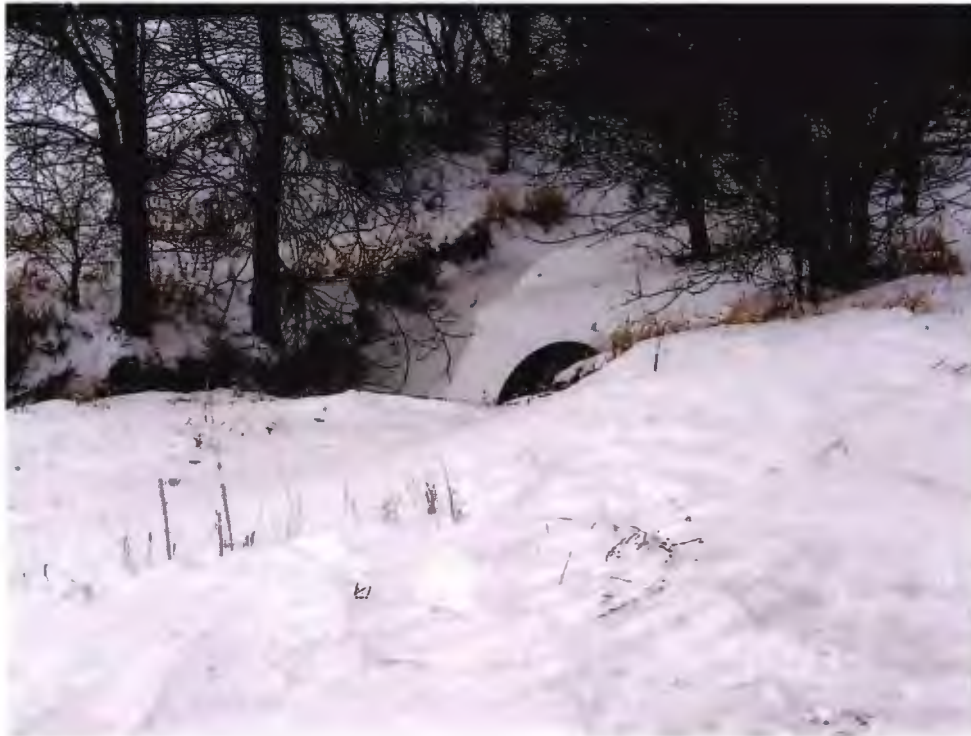
View west of ditch upstream from Stop #2

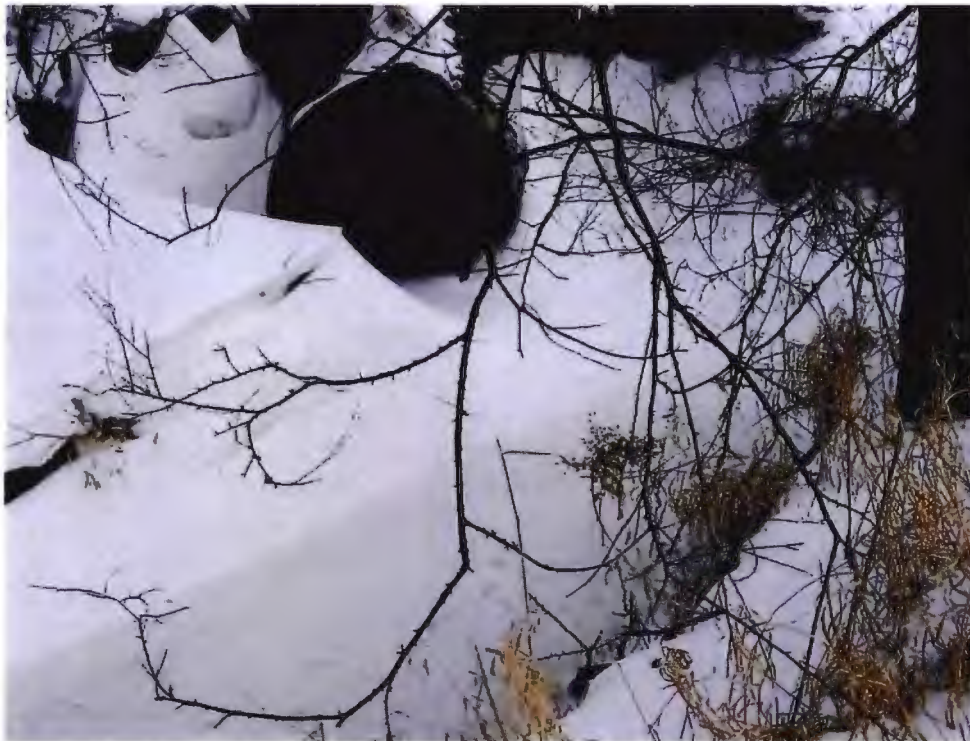
View east of upstream culvert inlet at Stop #2

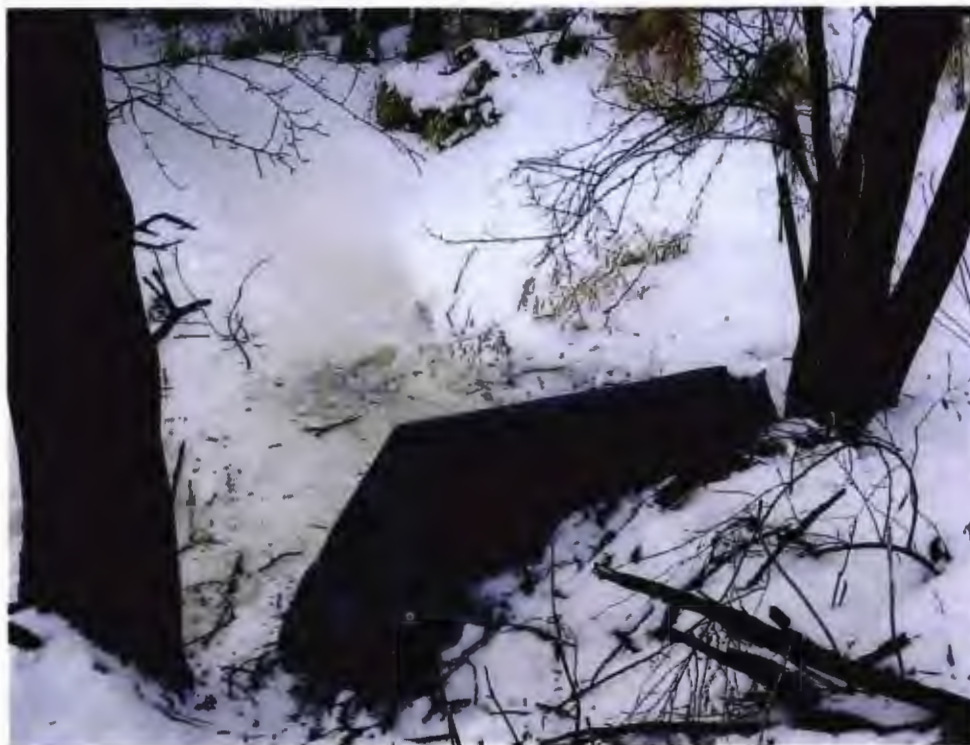
I proceeded to Stop #3. Stop #3 is located on road 7 about 1/2 mile north of road F. The surface of the liquid in the ditch at Stop #3 was frozen. I did not attempt to break through the ice to determine if there was unfrozen liquid below the ice. The ice had slight yellow/tan coloration. I observed plywood (or similar) wrapped with a tarp covering the inlet of the culvert. There were several sandbags placed at the base of the plywood/tarp to hold it in place (see attached photos). I dug through the snow at the downstream outlet of the culvert and found only ice. I did not attempt to break through the ice at the culvert outlet to look for unfrozen liquid.

View west of ditch upstream from Stop #3

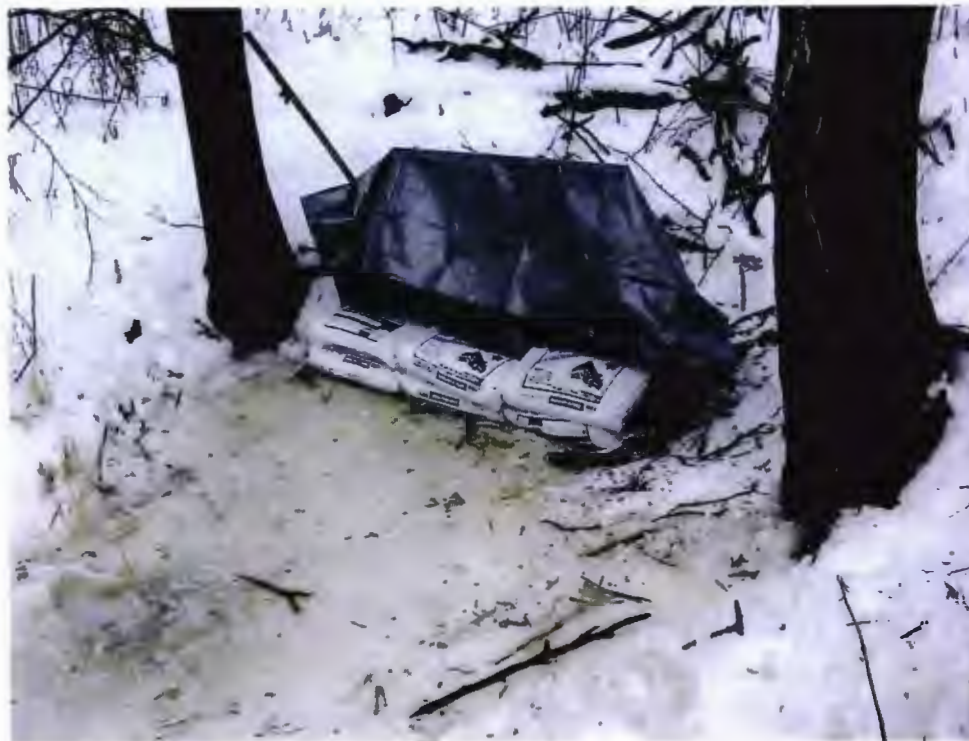
Containment structure in culvert inlet at Stop #3

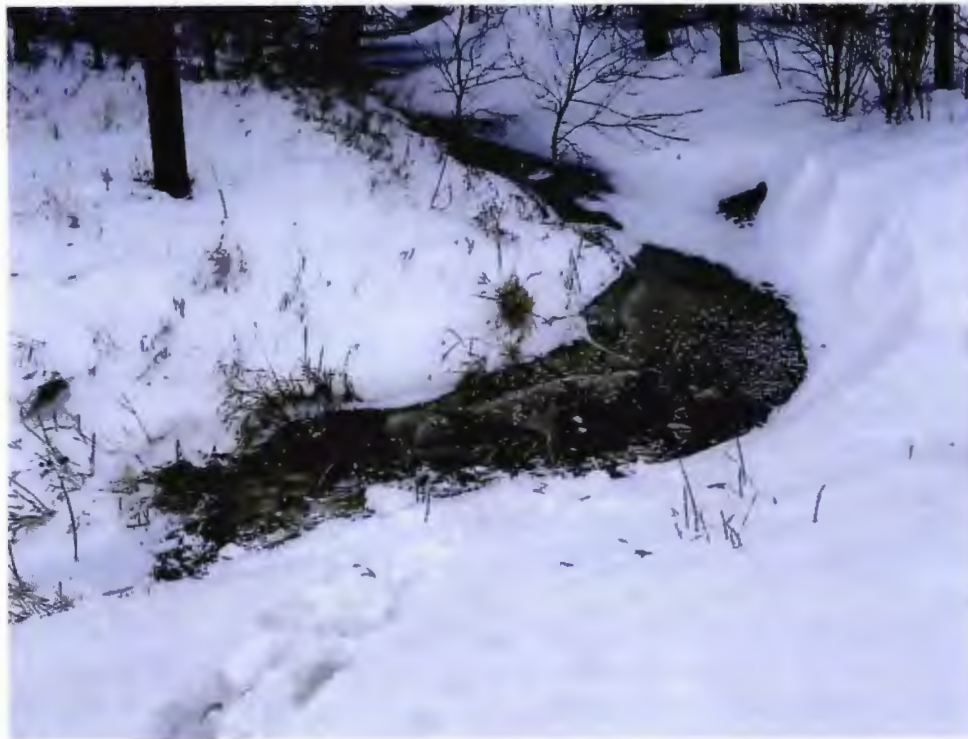
I proceeded to Stop #4. Stop #4 is located on road 8 about 1/2 mile north of road H. I observed brown-colored ice both upstream and downstream from Stop #4. Upstream from Stop #4, the ice was broken in many pieces as if it froze and the liquid below drained away (see attached photos).

View west of ditch upstream from Stop #4

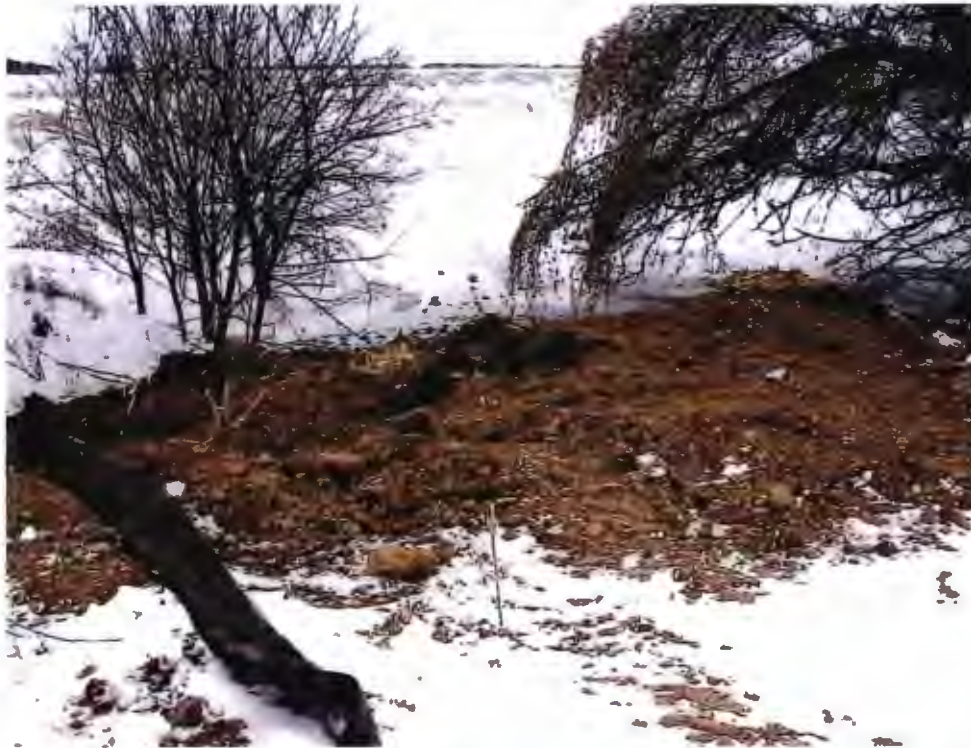
I proceeded to Stop #5. Stop #5 is located on a closed road (road 9) a short distance north of road J. I observed an earthen dam upstream from Stop #5. I did not see the hay bales or concrete rip-

View west of dam upstream of Stop #5

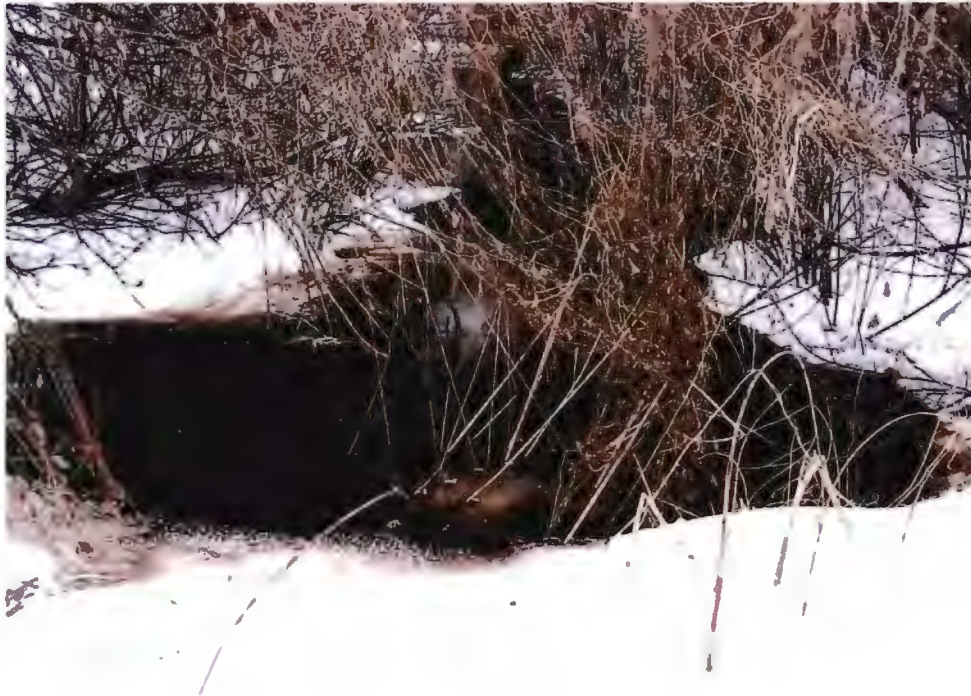
View east of ditch downstream from Stop #5

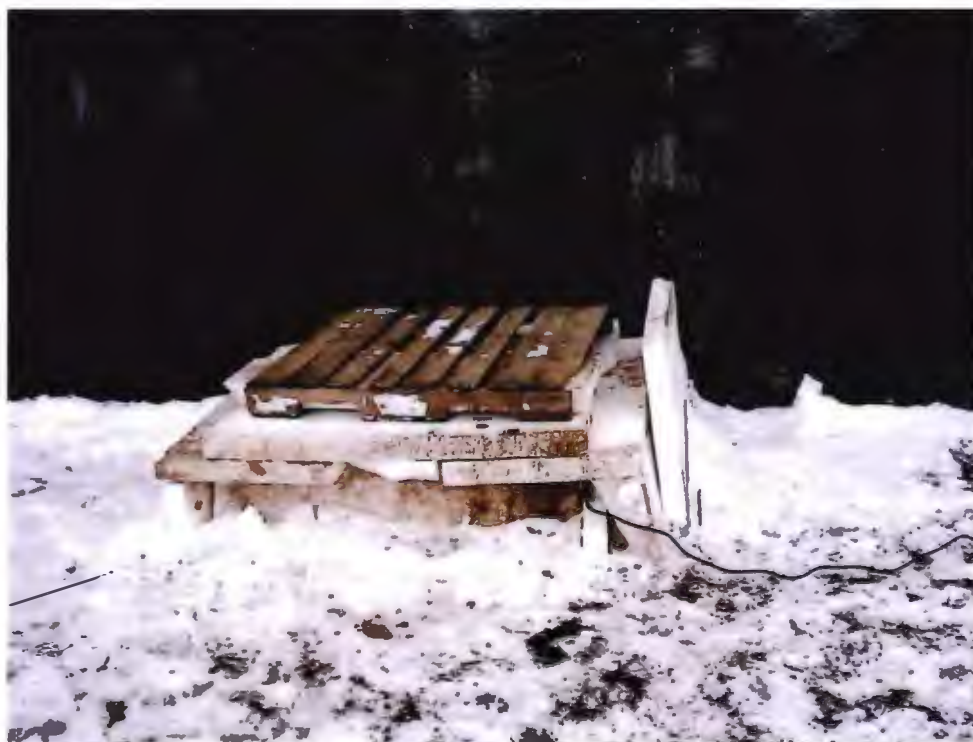
Insulation over piping well on digester w/out leak

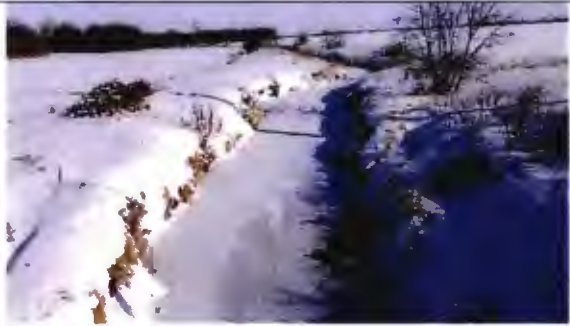
Clear Creek at this location was 99% ice/snow covered. There was a couple of open water areas, but site is currently not impacted from the AltEn LLC thin stillage discharge. Photo is looking north (upstream).

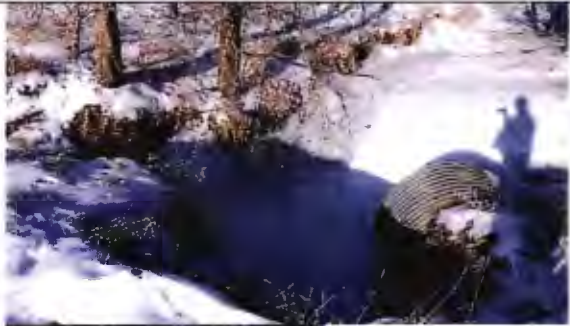
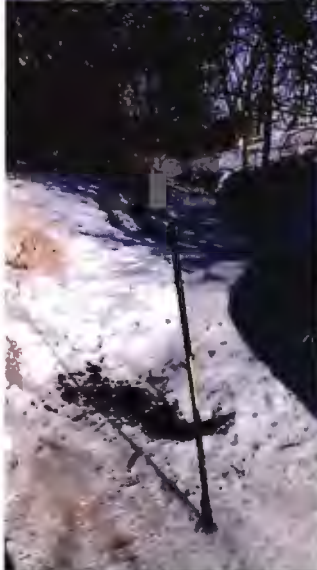
**STOP 2 – North of the Intersection of
COUNTY ROADS 6 & F**

I found no evidence of the AltEn LLC thin stillage discharge reaching this location. I chopped a hole in the ice (~10 inches thick) to the channel's substrate. It was completely frozen, with no water below the ice. Photos were taken looking west/northwest (upstream).

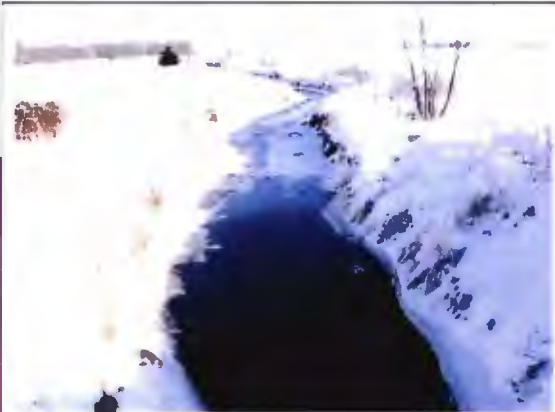
Nothing to see here other than water and ice;
no apparent impacts.

Photo looking north from Highway 66 bridge.

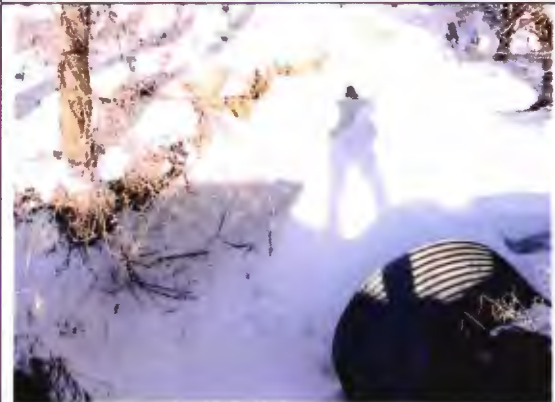
**STOP 2 – North of the Intersection of
COUNTY ROADS 6 & F – 0845 hrs.**

No apparent contamination; same as
described by Greg Michl 2-18-21.

Photo looking west.

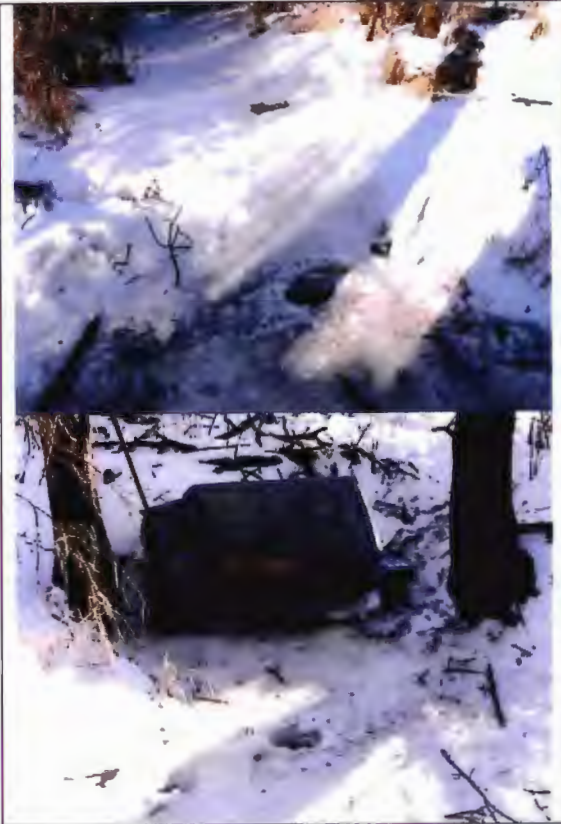
Top photo looking west.

Bottom photo looking east at containment structure.

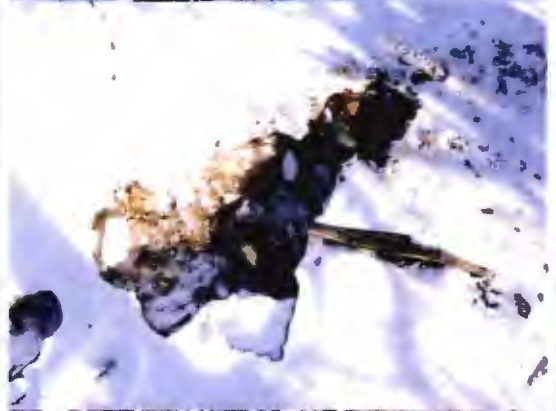
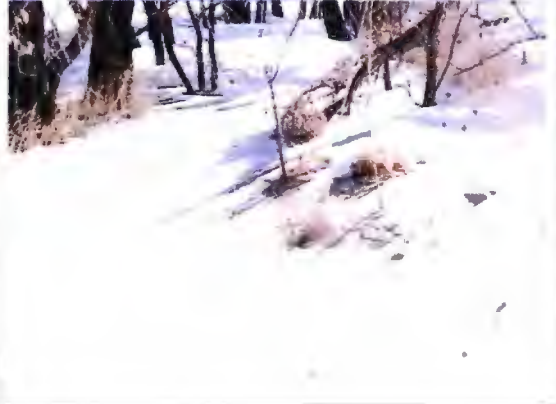
**STOP 4 – County Road 8, North of Road H
– 0905 hrs.**

Appears to be as described by Greg Michl on 2-18-21. Contamination evident.

Top two photos looking down at frozen contamination on west side of county road.

Bottom photo looking east from east side of county road.

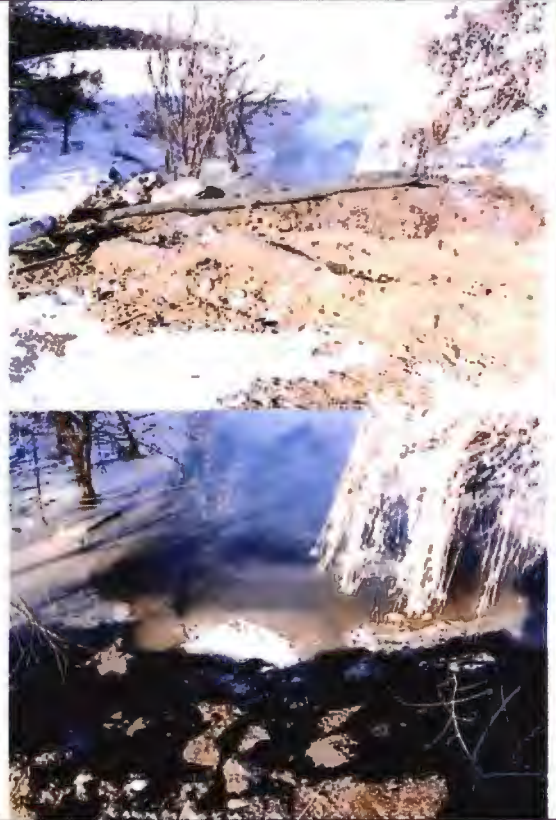
STOP 5 – UN-L Eastern Extension – North of County Roads 9 & J – 0915 hrs.

Generator and piping present, but no pumping going on.

Top photo (page 5). Looking east at frozen contamination.

Bottom photo (page 5). Looking north at overview of generator (not operating) and piping.

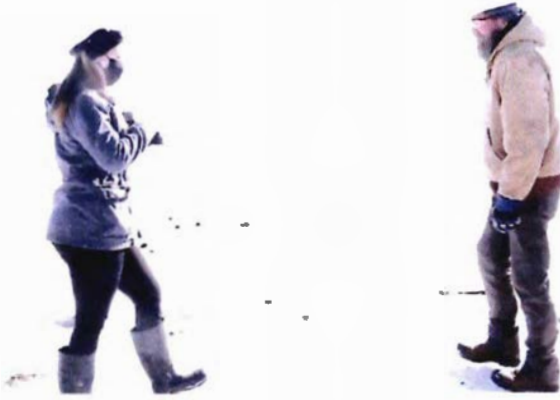
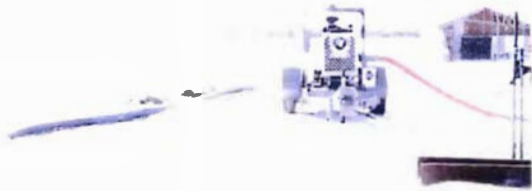
Facility pumping water from emergency lagoon to active wastewater lagoons in preparation for pumping material from north digester. NDEE Inspector Hillary Stoll on-site for inspection of emergency lagoon (see Photos below). Top photo looking east across "emergency lagoon." Bottom photo (looking south) shows water from "emergency lagoon" being pumped north to site wastewater lagoons.

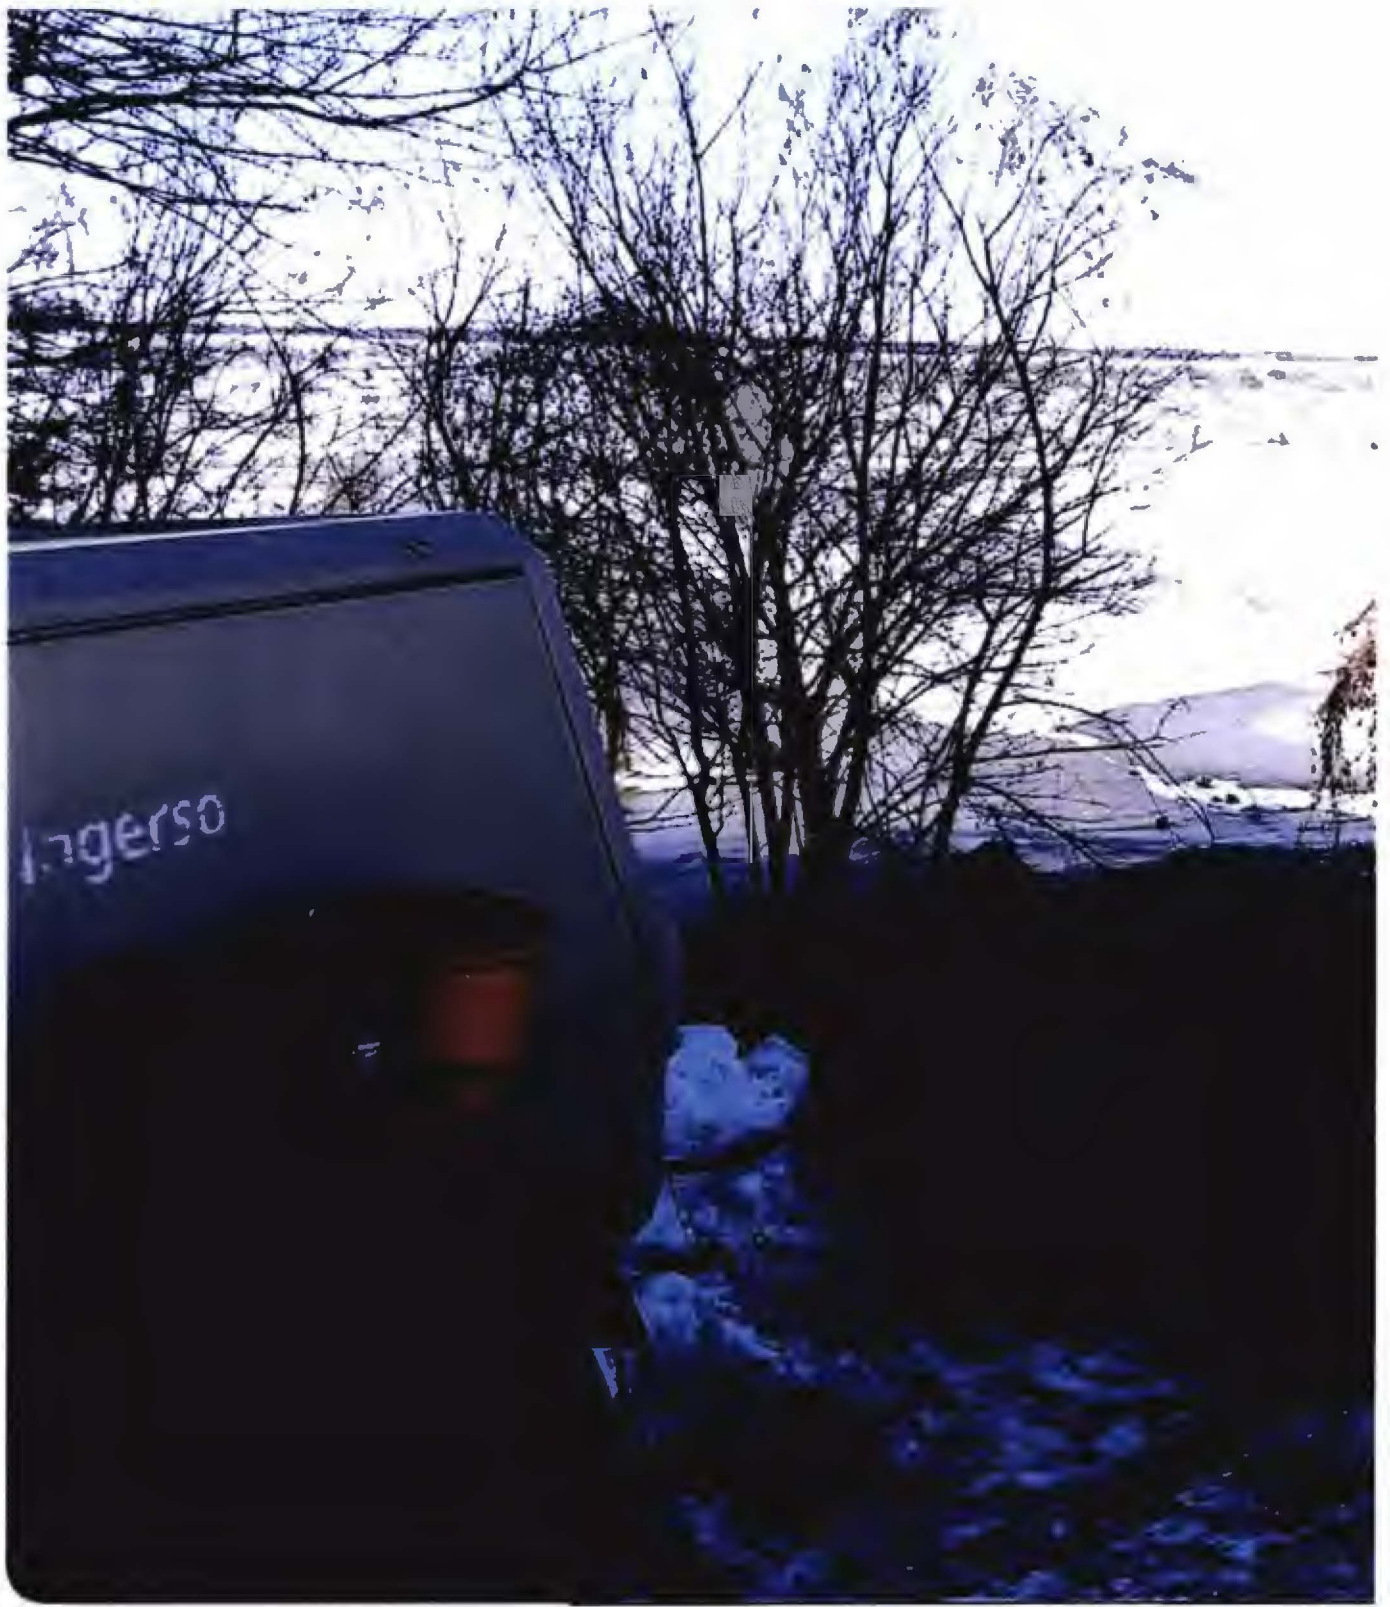
20210225469

I read your site visit published on the NDEE website today.
I was also examining the spill yesterday and took the photograph below where AltEn's contractor was pumping the spillage from Johnson Creek back to the lagoon from the intersection of county roads 9 and J.
